**NABI: WMATA – Duraflex Exhaust Connector Installation**

**Property and TopBus Number:**  
WMATA 325000 & 325500 – 8001 thru 8105.

**Issue:** Vibol Exhaust Connector

**Solution:** Replace existing Vibol connector with Duraflex connector

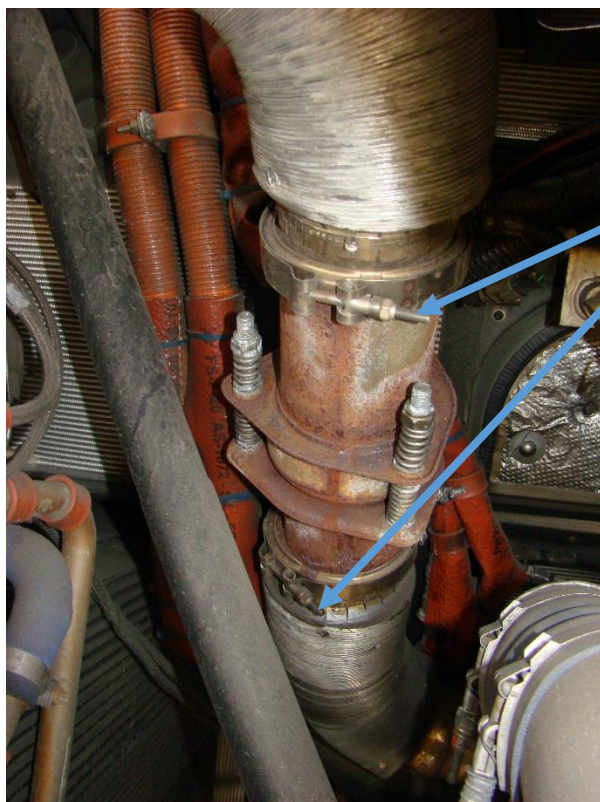
**Reason/ cause:** Vibol exhaust connector is too rigid

1. Park the bus on level surface and apply parking brake. Turn engine off.
2. Turn off the main battery disconnect switch.
3. Open the rear engine door.
4. Position the rear run switch to “off” so the vehicle cannot be started while performing this retrofit.
5. Locate & remove the two clamps fastening the existing Vibol connector (see below). Discard the Vibol connector & existing gaskets, clamps will be reused during reinstallation.
