# TECHNICAL SERVICE INFORMATION BULLETIN

TSIB 15-01, rev B		November 4, 2015
<b>TO:</b>	All Operators	
<b>TITLE:</b>	Steering Damper Mount Inspection	
<b>APPLICABILITY:</b>	All New Flyer Xcelsior Buses

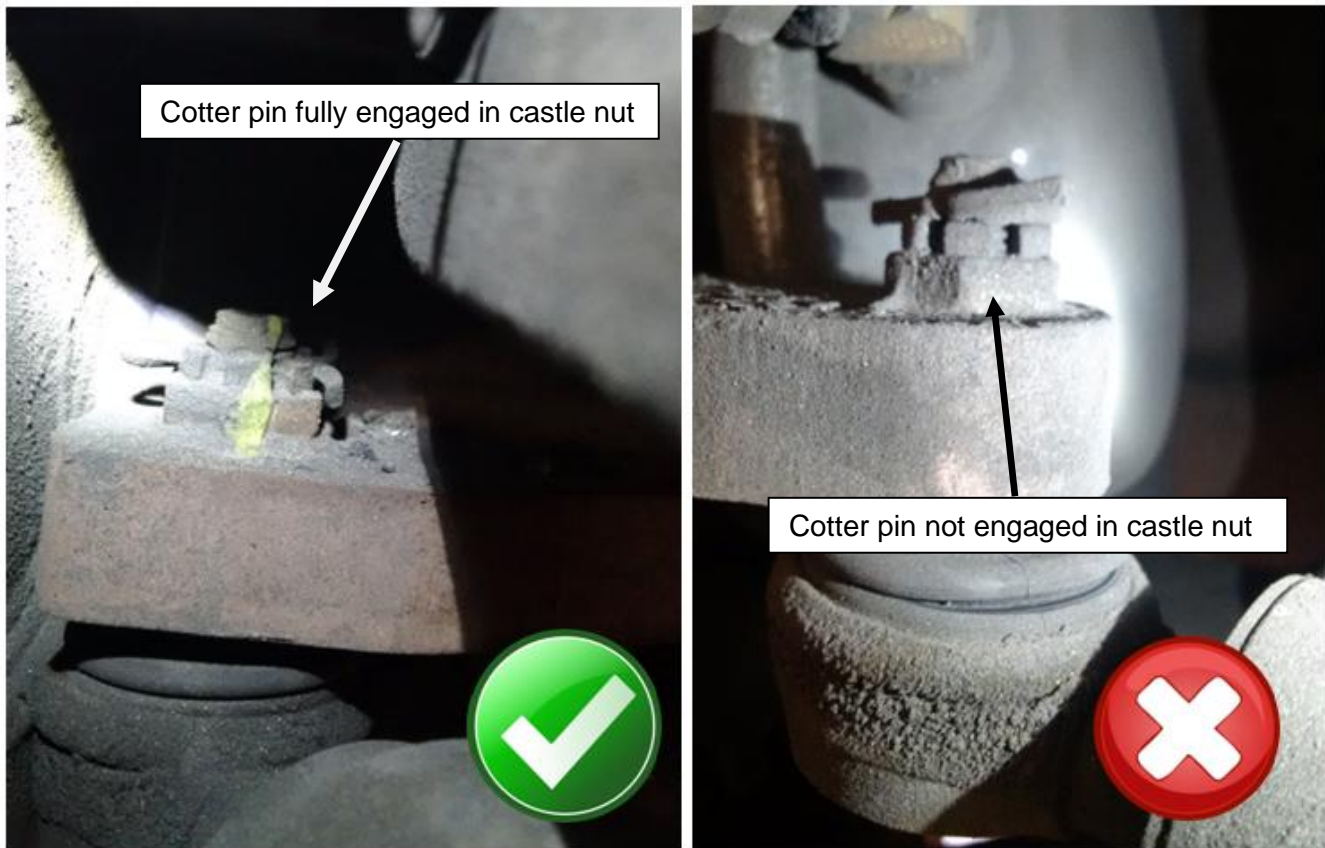
A loose steering damper will have reduced effectiveness and could lead to excessive vibration in the steering system.

Figure 1 demonstrates an acceptable installation on the left and a defective installation on the right.

**Figure 1: Typical examples of acceptable (left) and unacceptable (right) steering damper installations**

Damper and Mount Condition	Recommended Action
No issue found	No action required. Apply a torque stripe to the castle nut if none is present.
Cotter pin is missing (No play between ball studs and mounts)	Torque castle nut to 55 ft-lbs dry and install cotter pin (NF P/N 6360402). Ensure cotter pin fully engages castle nut. Apply a torque stripe to the nut.
Cotter pin does not fully engage castle nut (No play between ball studs and mounts)	Remove and discard cotter pin. Install a washer (NF P/N 579798) between the castle nut and mount. Torque the castle nut to 55 ft-lbs dry. Install a new cotter pin (NF P/N 6360402). Ensure cotter pin fully engages castle nut. Apply a torque stripe to the nut.
Free play between the damper ball studs and mounting plates	Remove the existing affected mount and replace it with a new chassis-side (NF P/N 579980) or axle-side (NF P/N 583640) mount according to the instructions in the New Flyer Service Manual. Replace the damper, both castle nuts, and both cotter pins at this time.

Unattached steering damper joints (Ball joint stud completely separated from mount)	Remove the existing affected mount and replace it with a new chassis-side (NF P/N 579980) or axle-side (NF P/N 583640) mount according to the instructions in the New Flyer Service Manual. Replace the damper, both castle nuts, and both cotter pins at this time.
