**WMATA – EGR Vent Line P-Clamp Repacement**

**Property and TopBus Number:**  
WMATA 325000 & 325500 – 8001 thru 8105.

**Issue:** EGR Vent Line P-Clamps

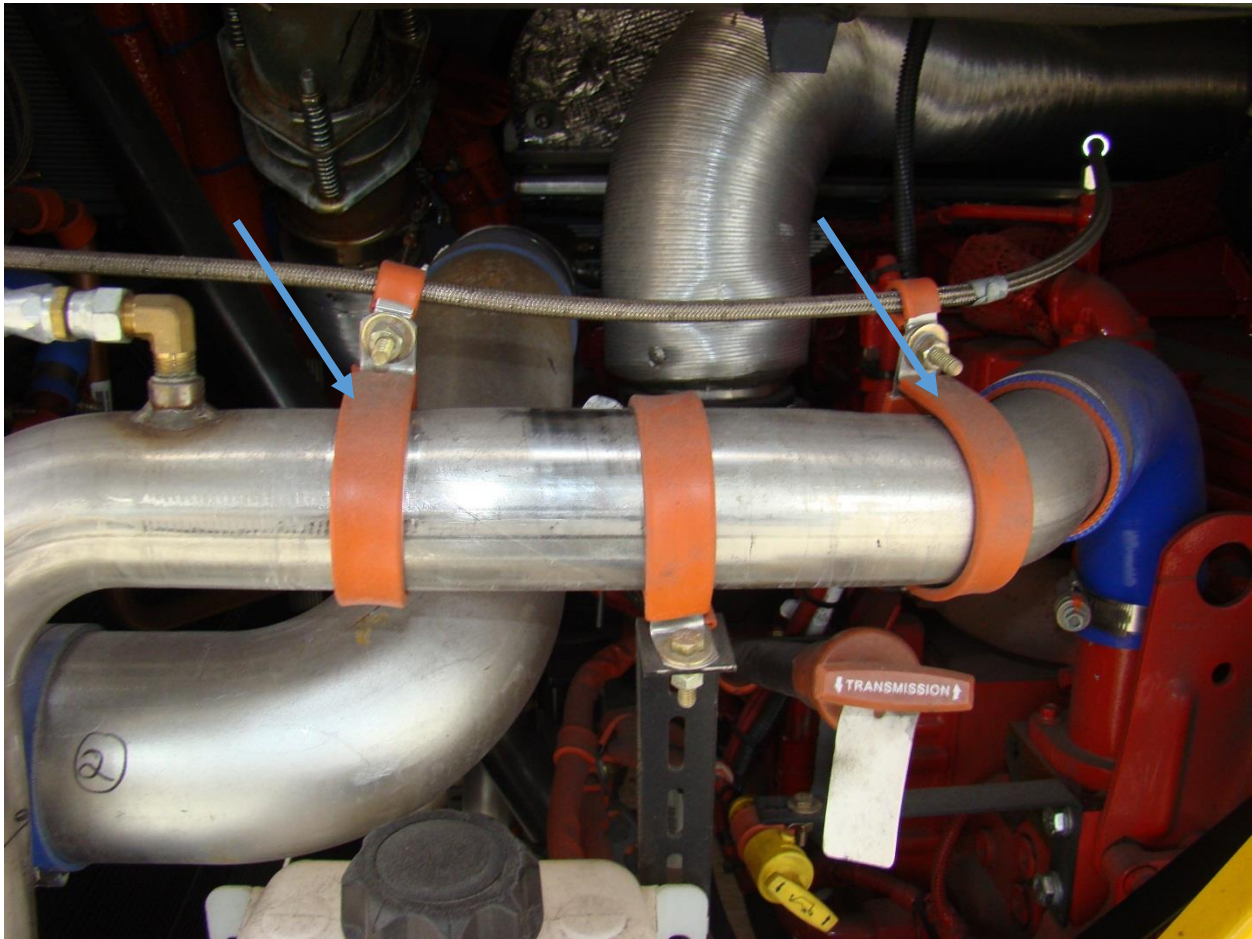
**Reason/ cause:** P-Clamps for the EGR vent line are too large allowing the vent line to fall out of position

1. Park the bus on level surface and apply parking brake. Turn engine off.
2. Open the rear engine door.
3. Locate & remove the two p-clamps that fasten the EGR vent line to the coolant pipe (see below). Discard existing p-clamps, hardware to be reused in step 4.
