## INSTRUCTION TO SERVICE

**ITS: 6006**

| <b>SECTION:</b> | 231 Coolant System |
| <b>SUBJECT:</b> | Revise surge tank low coolant level sensor harness rework |

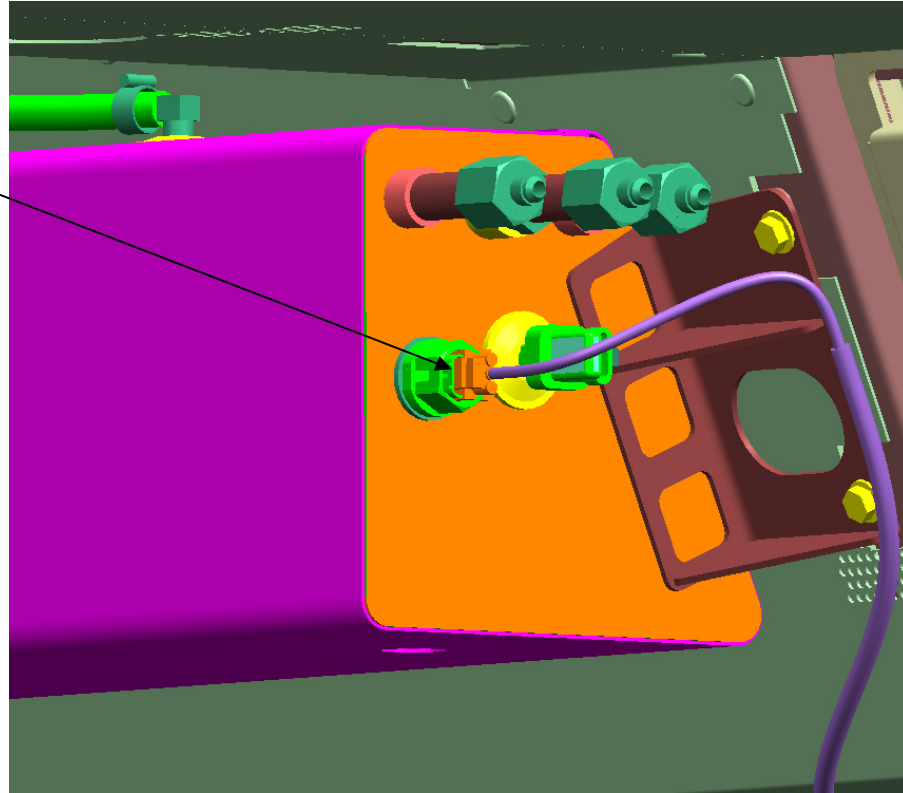
**Figure 1: Existing Surge Tank Low Coolant Derate Sensor**

3. Disconnect the existing coolant derate sensor harness and examine the terminals on both the harness connector and the low coolant sensor for signs of corrosion. If corrosion is present then the sensor will need to be replaced with new sensor (NF P/N 473480).

4. Cut off the existing 3 circuit tower as close as possible to the connector of the disconnected harness and terminate each wire with the supplied terminal (NF P/N 108871) and wire seal (NF P/N 108872).

5. Insert wire 140EN46#2 (red) into supplied 3-pin shroud connector (NF P/N 104558) at cavity A (SIG).
6. Insert wire 140EN46#2 (black) into supplied 3-pin shroud connector (NF P/N 104558) at cavity C (GND).

7. Insert connector plug (NF P/N 102904) into supplied 3-pin shroud connector (NF P/N 104558) at cavity B.
8. Connect newly pinned shroud connector to supplied extension harness (NF P/N 584150).

9. Connect the new extension harness to the existing surge tank low coolant derate sensor harness.
10. After installation the connection between the main harness and the new extension harness and between the new extension harness and the low coolant sensor are to be wrapped with self fusing tape NF P/N 6411846. Approx. 12” of tape for each connection.
