**NABI: DART Horn Orientation**

Property name and Top bus number: DART 304500, 306500, 313000, 314000, 323000

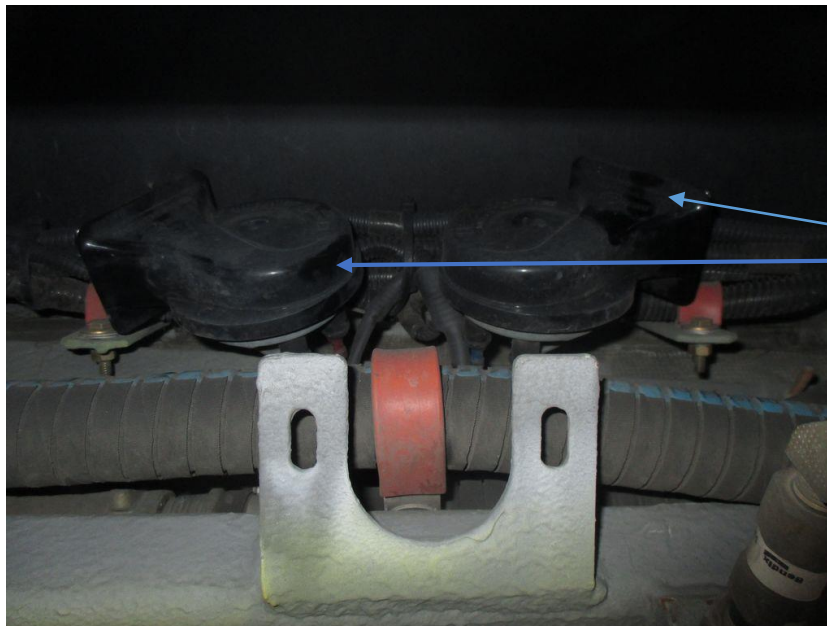
Issue: The horns are failing

Reason/ cause: The horns are holding water

Horns oriented in a way that the water cannot run out

4. If the horn is oriented in a way that the water cannot run out then re-orient the horn
