INSTRUCTION TO SERVICE

ITS: 5907

SECTION:	231 Coolant System
WRITTEN BY:	Mike Pearson
SUBJECT:	Add Low Floor EMP Radiator Ground Straps

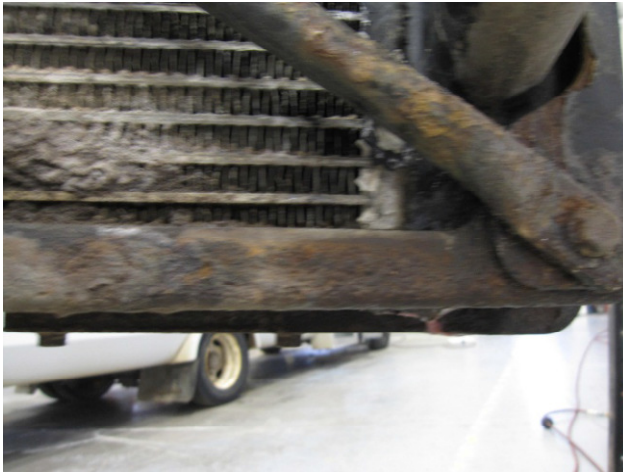
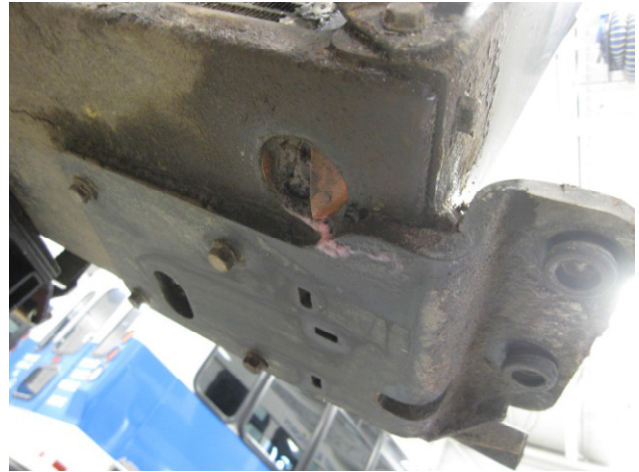
Figure 2: Gen II Examples.

These voltage levels are capable of causing highly-accelerated heat exchanger corrosion.

Accelerated corrosion was located by the radiator outlet and was limited to vehicles running in icy or snowy winter locations. This corrosion has been determined to be caused by stray voltage carried by the coolant. If the pipes are separated from the radiator via silicone (non-conducting) hoses and the pipes and radiator are not on the same ground plane, electrolysis can occur between the pipes and the radiator. Grounding the radiator and pipes to the vehicle chassis eliminates the electrical potential, stopping the electrolytic corrosion. See Figure 2 for images of accelerated corrosion.

Voltage potential between radiator and coolant pipes can be eliminated by grounding the Mini-Hybrid® cooling system and coolant pipes to the vehicle chassis.
