## INSTRUCTION TO SERVICE

**ITS: 5909**

| <b>SUBJECT:</b> | Add EMP Radiator Ground Straps |

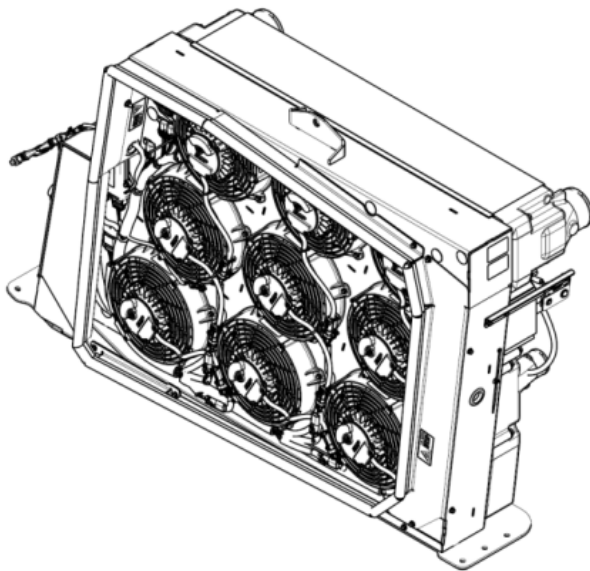
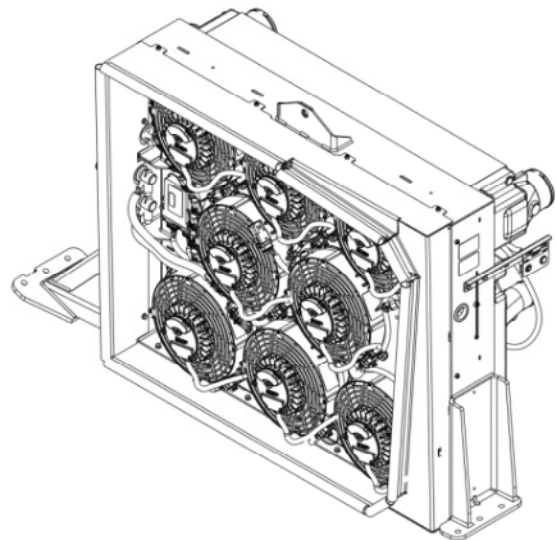
**Figure 1: Mini-Hybrid® Cooling Systems**

2020056000, 2020056032 and 2020070000

2020069000

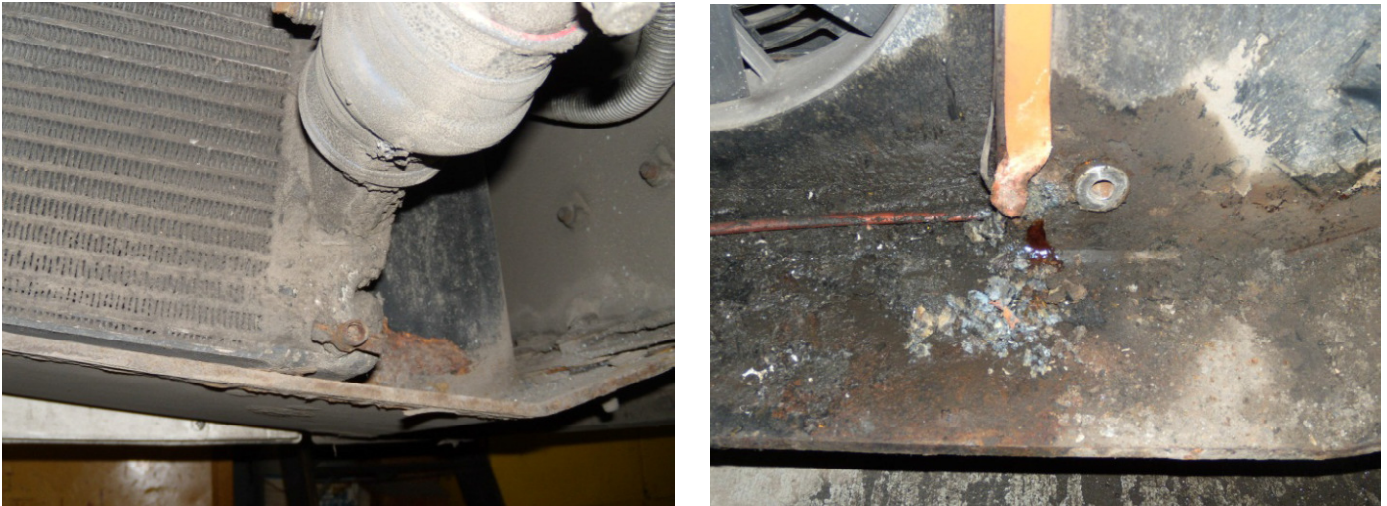
Figure 2: Gen III Examples.

Accelerated corrosion was located by the radiator outlet and was limited to vehicles running in icy or snowy winter locations. This corrosion has been determined to be caused by stray voltage carried by the coolant. If the pipes are separated from the radiator via silicone (non-conducting) hoses and the pipes and radiator are not on the same ground plane, electrolysis can occur between the pipes and the radiator. Grounding the radiator and pipes to the vehicle chassis eliminates the electrical potential, stopping the electrolytic corrosion. See Figure 2 for images of accelerated corrosion.

Voltage potential between radiator and coolant pipes can be eliminated by grounding the Mini-Hybrid® cooling system and coolant pipes to the vehicle chassis.
