INSTRUCTION TO SERVICE

ITS: 5930	
SECTION:	231 Coolant System
WRITTEN BY:	Mike Pearson
SUBJECT:	Add EMP Radiator Ground Straps

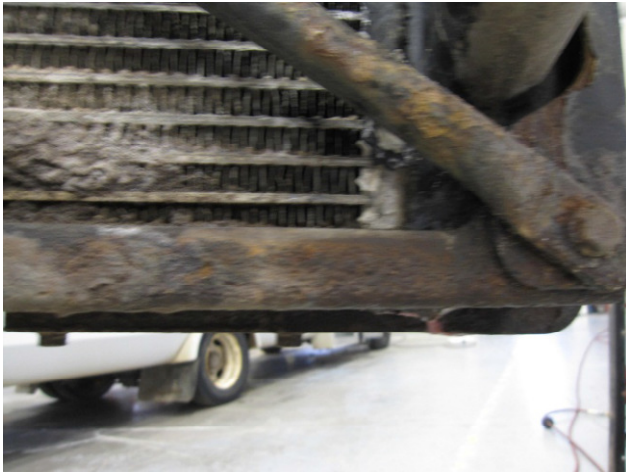
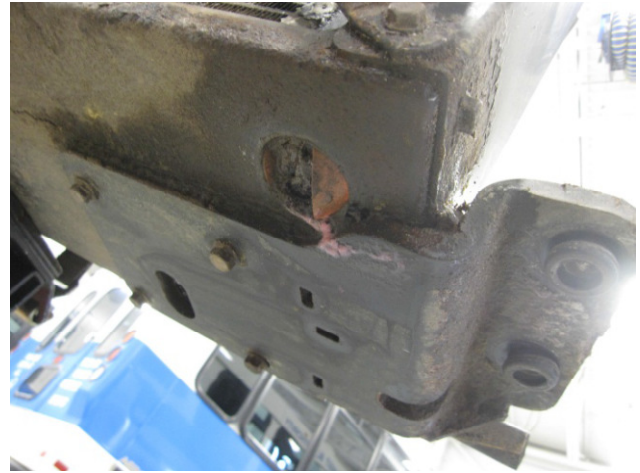
Figure 2: Gen II Examples.

Accelerated corrosion was located by the radiator outlet and was limited to vehicles running in icy or snowy winter locations. This corrosion has been determined to be caused by stray voltage carried by the coolant. If the pipes are separated from the radiator via silicone (non-conducting) hoses and the pipes and radiator are not on the same ground plane, electrolysis can occur between the pipes and the radiator. Grounding the radiator and pipes to the vehicle chassis eliminates the electrical potential, stopping the electrolytic corrosion. See Figure 2 for images of accelerated corrosion.

Voltage potential between radiator and coolant pipes can be eliminated by grounding the Mini-Hybrid® cooling system and coolant pipes to the vehicle chassis.
