**NABI: WMATA – Exhaust Support Bracket**

**Property and TopBus Number:**  
WMATA 325000 & 325500 - Fleet Numbers: 8001 thru 8105.

**Issue:** Exhaust Support Bracket

Work Instruction Number:  
L3/FSV-321

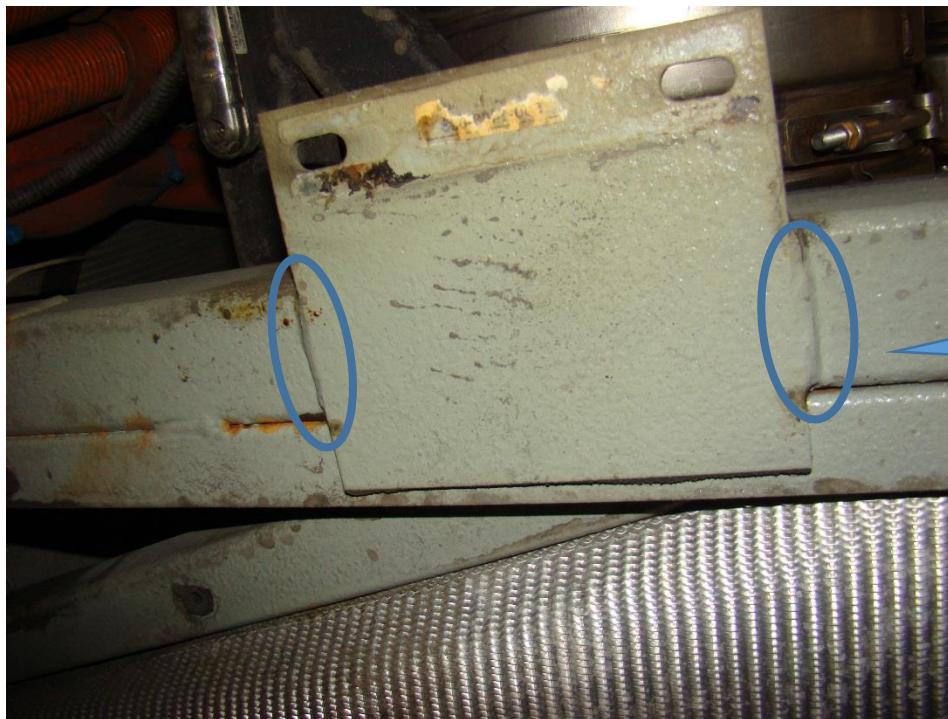
1. Park the bus on level surface and apply parking brake. Turn engine off.
2. Turn off the main battery disconnect switch.
3. Open the rear engine door.
4. Position the rear run switch to “off” so the vehicle cannot be started while performing this retrofit.
5. Locate & inspect the exhaust support bracket. Check for cracked or broken welds & verify that it is on the correct location (see below & next page). **Note: Exhaust pipe removed for clarity.**

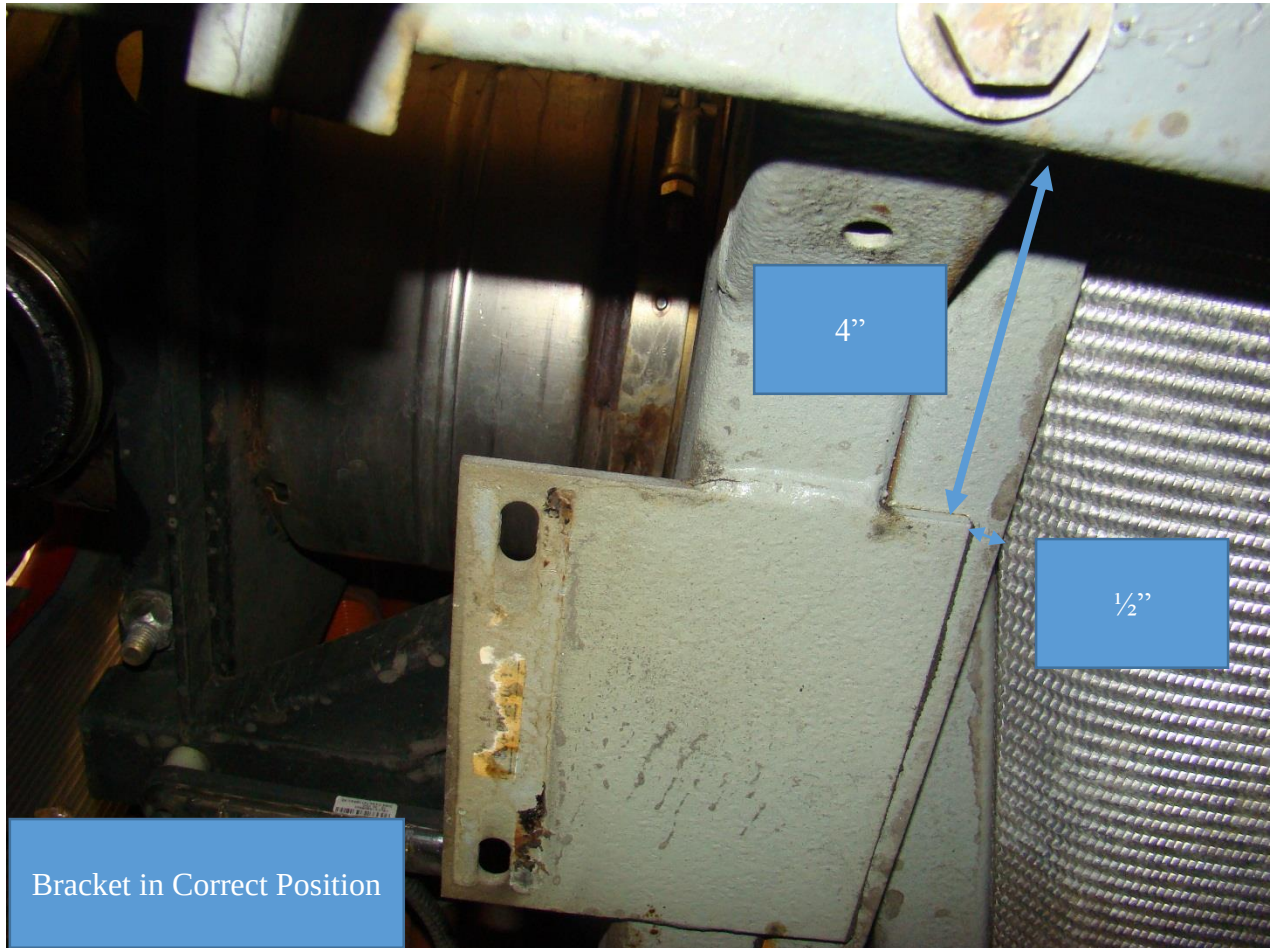
Check for  
cracked or  
broken welds.
