**January 16, 2015**

## **Clunk From Front Suspension When Driving at Low Speed Over Bumps or Turning**

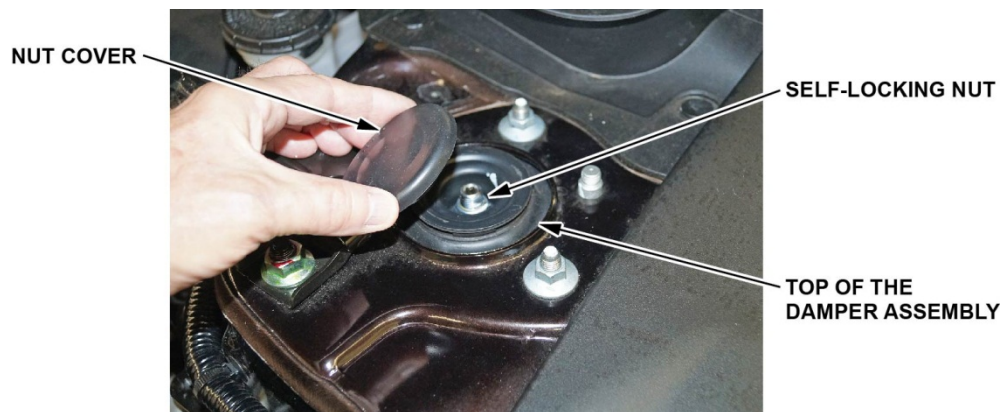
At least one of the self-locking nuts at the top of the front damper/spring assemblies is loose.

1. Remove the nut covers at the top of both front damper assemblies.
