Sun Visor May Move from the Stowed Position

Service Category Vehicle Interior

Section Interior Panels/Trim

YEAR(S)	MODEL(S)	ADDITIONAL INFORMATION
2010 - 2013	Highlander	WMI(s): 5TD Plant Code(s): S

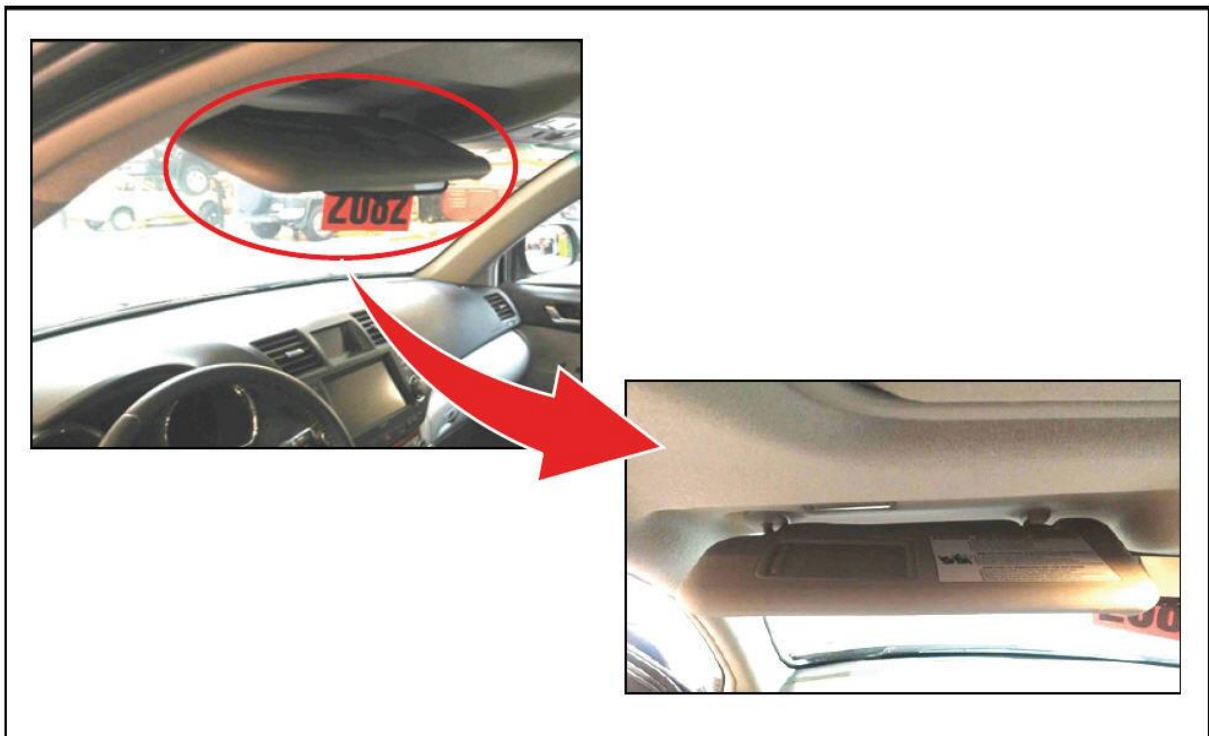
Figure 1.

Some 2010 – 2013 model year Highlander vehicles may exhibit a condition in which the driver side or passenger side Sun Visor may move from the stowed position, or may not completely stow flush against the headliner. Follow the Repair Procedure in this bulletin to address this concern.

1. Confirm the condition described in the Introduction is present.
2. Replace the Sun Visor.
Refer to the Technical Information System (TIS), applicable model and model year Repair Manual:
 - 2010 Highlander:
Vehicle Interior – Interior Panels/Trim – “Interior: Roof Headlining: [Removal/Installation](#)”
 - 2011 Highlander:
Vehicle Interior – Interior Panels/Trim – “Interior: Roof Headlining: [Removal/Installation](#)”
 - 2012 Highlander:
Vehicle Interior – Interior Panels/Trim – “Interior: Roof Headlining: [Removal/Installation](#)”
 - 2013 Highlander:
Vehicle Interior – Interior Panels/Trim – “Interior: Roof Headlining: [Removal/Installation](#)”
3. Confirm condition is no longer present.
