Display Audio System Firmware Update (Fujitsu Ten)

YEAR(S)	MODEL(S)	ADDITIONAL INFORMATION
2015	ES300H, ES350

Introduction

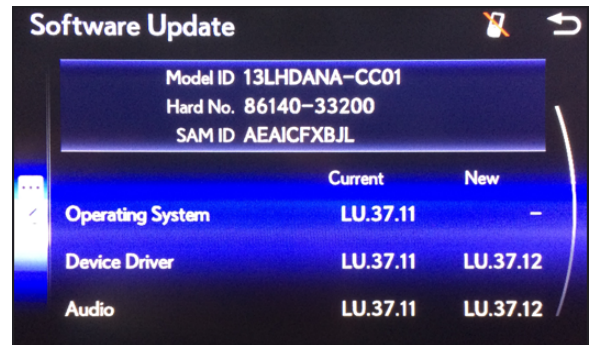
Figure 9.

- K. Confirm the *Operating System* current version is older than the new version.

- If the current version is LU.37.12 or greater, **STOP** – this bulletin does NOT apply.
- If the current version is less than LU.37.12, proceed to the next step.
