MIL "ON" DTC P0A0F, P3190, P3191, P0171 Due to Purge VSV Vacuum Line Separation

Service Category Engine/Hybrid System

YEAR(S)	MODEL(S)	ADDITIONAL INFORMATION
2011 – 2013	CT200H

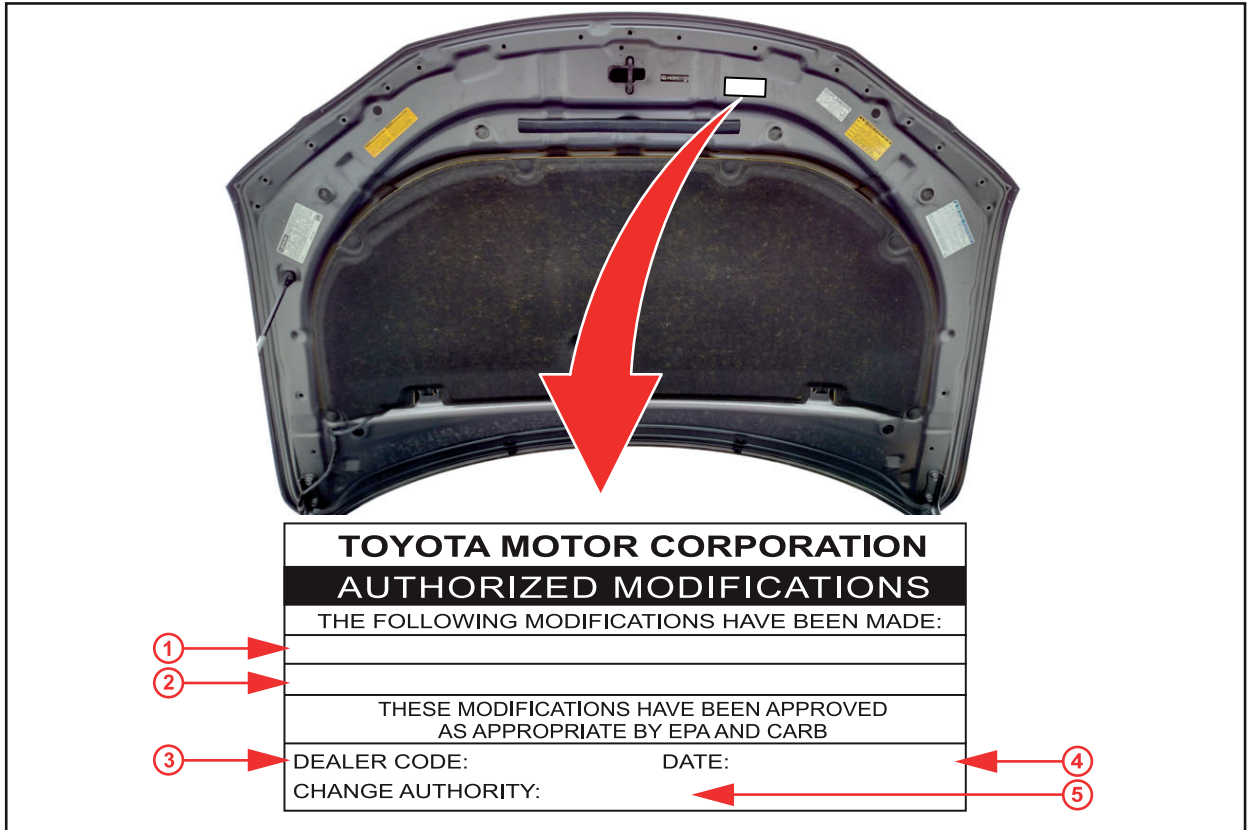
Figure 1. Location of Authorized Modifications Label on 2011 – 2013 CT 200h

2. Check for the Authorized Modifications Label affixed to the vehicle in the location shown in Figure 1. Confirm if the ECM (PCM) calibration has been updated. If the calibration ID listed is NOT the latest ECM (PCM) calibration — go to step 3.

4. Install the Authorized Modifications Label.
 - A. Using a permanent marker, enter the following information on the label:
 - ECM part number [*Refer to the **Parts Information** section for the **NEW PART NUMBER***]
 - Calibration ID(s) [*Refer to the **Calibration Information** section for the **NEW CALIBRATION ID***]
 - Dealer Code
 - Repair Date
 - Change Authority [***This bulletin number***]
 - B. Affix the Authorized Modifications Label to the vehicle at the location shown in Figure 1. The Authorized Modifications Label is available through the MDC, P/N 00451-00001-LBL.
5. Test drive the vehicle to confirm proper vehicle operation.
