FOR LIMITED SERVICE CAMPAIGN FLB CERTAIN 2010 MODEL YEAR RX 450h OXYGEN SENSOR REPLACEMENT

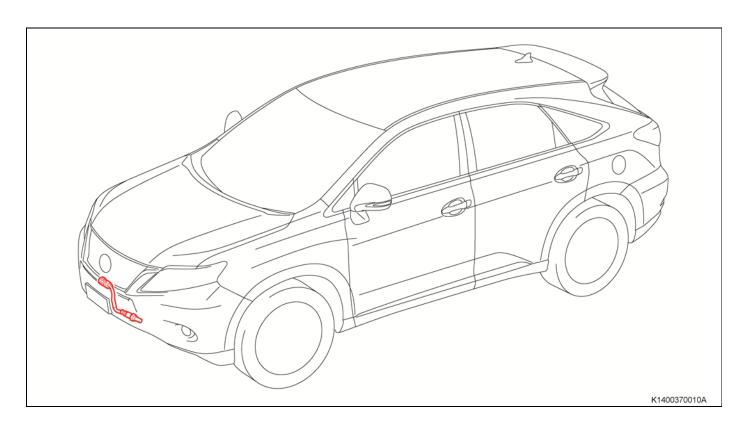
The subject vehicles are equipped with an oxygen sensor with an attached wire harness. Due to the oxygen sensor wire harness routing and engine vibration, the harness may become damaged over time. If the wire harness becomes damaged, the Check Engine warning lamp () may illuminate.

Lexus has designed a new oxygen sensor with a different wire harness and bracket to prevent this condition from occurring in the future.
