LED Headlight Housing Fracture & Condensation Accumulation

Service
Category Vehicle Exterior

Section Lighting (ext)

YEAR(S)	MODEL(S)	ADDITIONAL INFORMATION
2014 – 2015	IS250, IS350	VDS(s): BE1D2, BF1D2, CE1D2, CF1D2

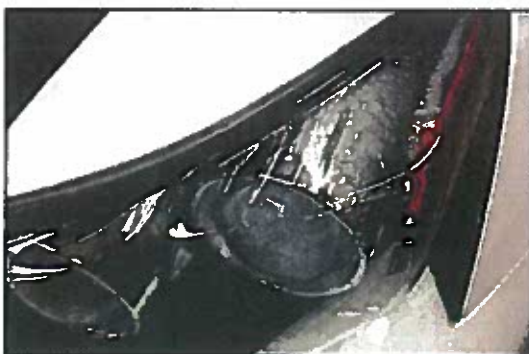
These conditions most often occur in cold weather climates. They may occur on one or both headlights, and may be a result of an opening/fracture near the uppermost mounting tab of the headlight. The headlight housing has been revised to address these conditions.

Figure 1. Example of Headlight Condensation

After reviewing this Service Bulletin, confirm the condition of BOTH headlights' mounting tabs and replace as necessary according to the procedures in this bulletin.

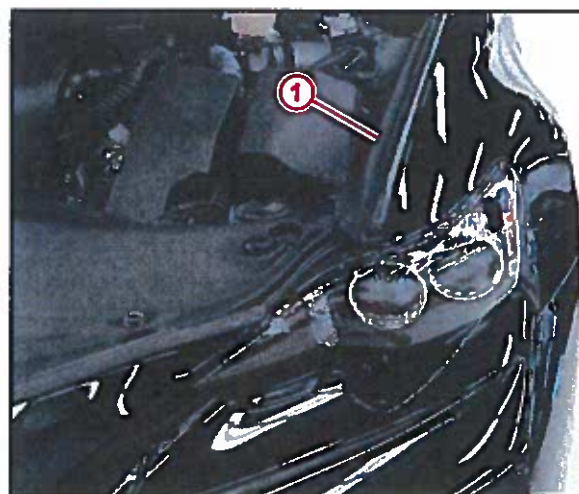
Figure 2.

A. Partially remove the hood to front fender seal (upper front fender protector) to access a view of the uppermost headlight tab.

1 Hood to Front Fender Seal

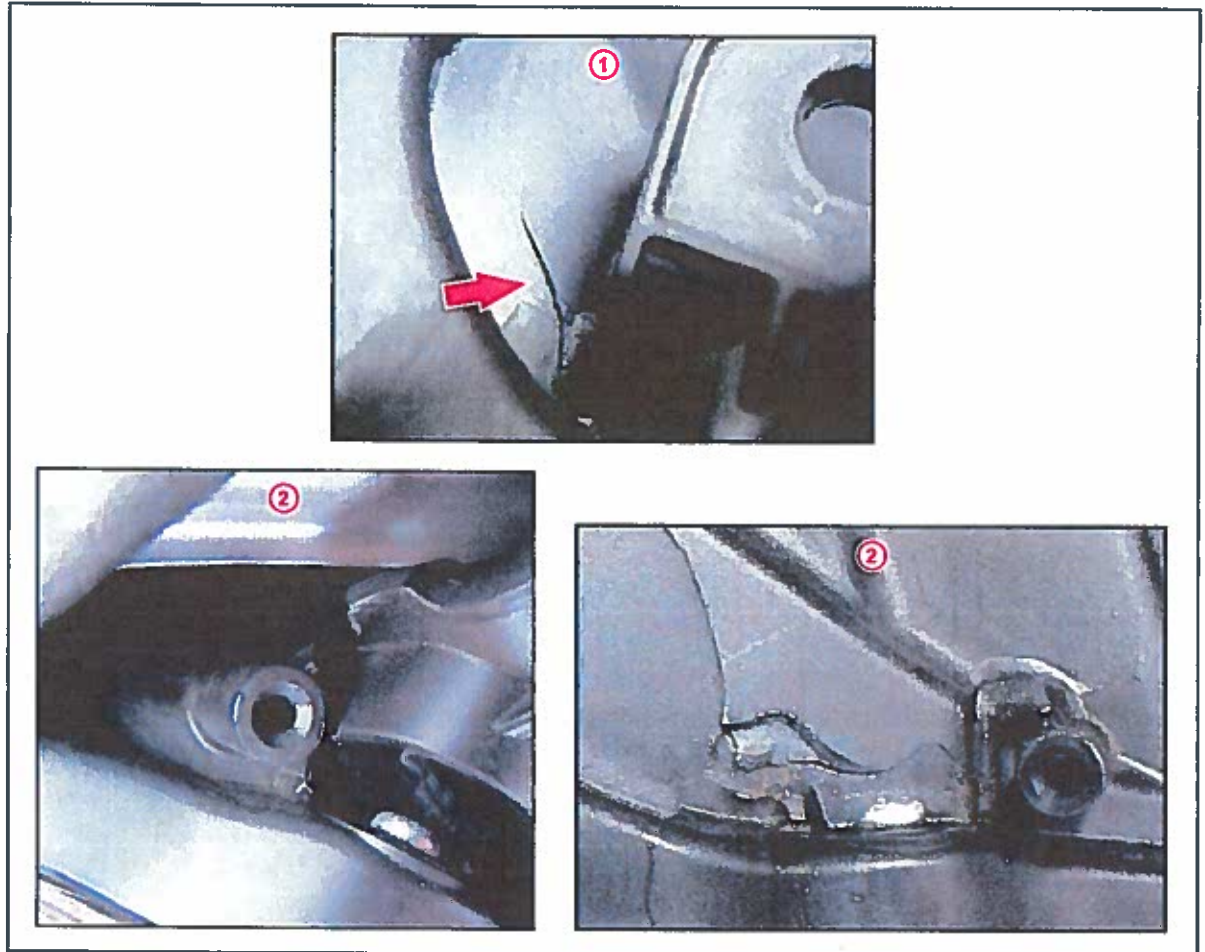
B. Inspect for signs of damage or mounting tab separation. (See Figure 4.)

Figure 4. Examples of Damage (Headlight Removed from Vehicle)

1 Fracture

2 Mounting Tab Separation

2. Replace the affected headlight(s).

If the headlight assembly was saturated with water at any point, replace both of the installed Headlamp Control Computer Sub-assemblies.

After the headlight body gaskets are removed, be sure to replace them with NEW ones. Failure to do so may cause water ingress.
