Lexus Enform Remote Start Inoperative

Service Category Audio/Visual/Telematics

Section Cellular Communication

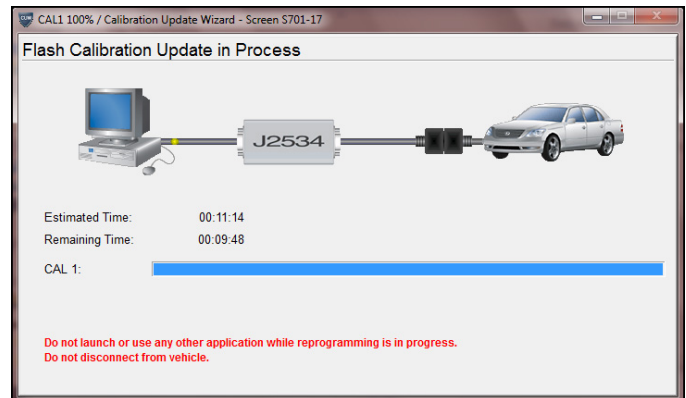
Figure 1.

During reprogramming the progress bar on the Calibration Update Wizard screen may show complete while the Remaining Time still shows several minutes. Refer to the Remaining Time to accurately determine when the update will complete.
