Paint Stains Under Rapgard

Service Category Vehicle Exterior

Section Paint/Coatings

YEAR(S)	MODEL(S)	ADDITIONAL INFORMATION
2008 – 2015	FR-S, iQ, iQ EV, tC, xB, xD

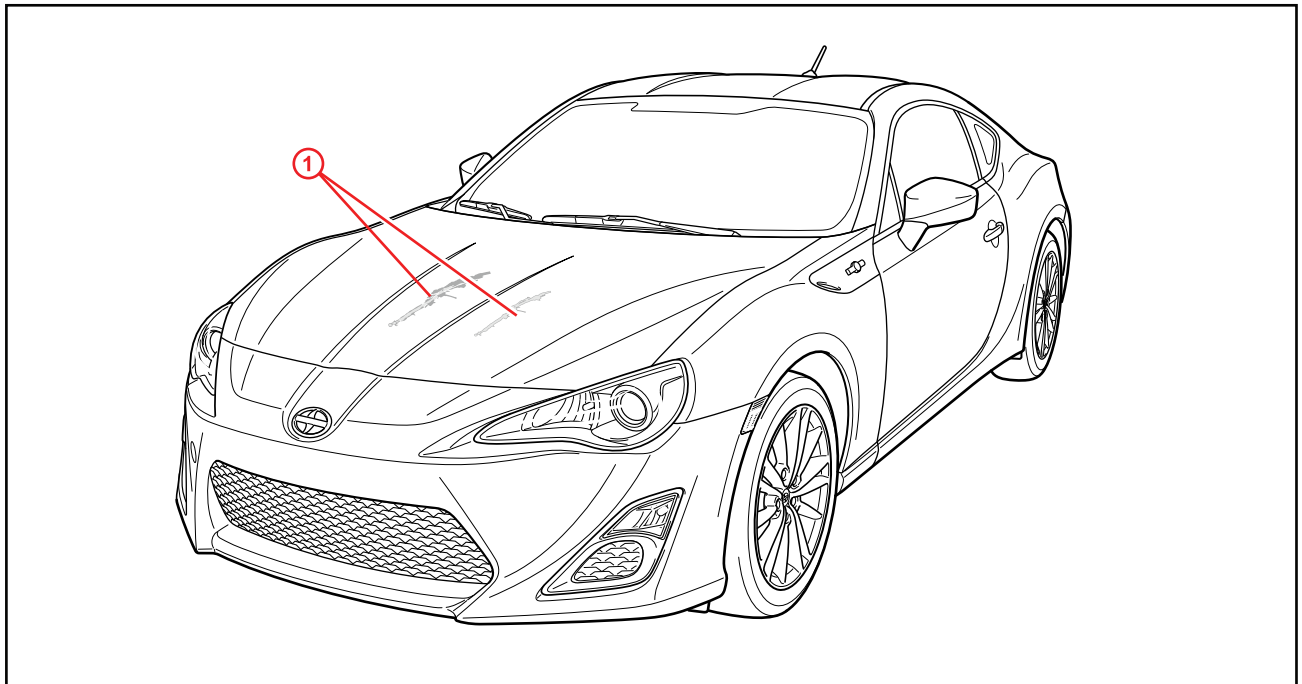
Figure 1.

On some vehicles, when Rapgard™ is removed, the paint may have a stained appearance. These stains appear to be under the clear coat (repainting this area is not necessary). The stain patterns are usually under wrinkles in the Rapgard™. These wrinkles sometimes trap water and cause the paint to stain from the trapped moisture, especially on horizontal surfaces, such as the hood, roof, and trunk. Stains can be removed by heating the stained surface to remove the trapped moisture.

1	Stains
----------	---------------

1. Use the aluminum foil or damp cloth to cover plastic/rubber parts that are near the stain.
2. Apply heat to the stain using an infrared lamp or heat gun.

Apply heat for 5 – 10 minutes at 158°F – 176°F (70°C – 80°C). Do NOT allow the surface to become hotter than 176°F (80°C). Measure the temperature with a thermometer.

3. After applying heat for 5 minutes, examine the area to determine if the stain has been removed. If the stain still exists, continue to apply heat and re-examine the stain 5 minutes later.
