**Transfer Case Input Shaft Leak**

13-15MY 4runner

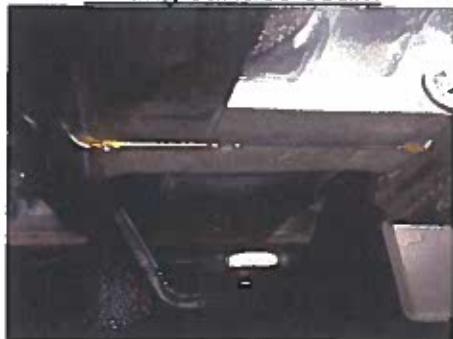
Mating surface seam

Certain vehicles may exhibit a leak from the input shaft seal on the transfer case assembly. This leak is typically first identified by fluid collecting at the bottom of the seam between the transmission output and transfer case input mating surfaces. See example photos below:

- Please create a TAS case and contact Technical Assistance (TAS) to submit details on any vehicle identified matching the condition described in this document prior to repair.
- If you are attempting to contact TAS on a weekend or TMS holiday, continue with diagnosis and submit the requested information on the next available work day. Retain all replaced parts and technician notes for possible review with TMS TAS Product Engineer.
