MIL "ON" DTC P2111 and/or P0A0F After Cold Soak

YEAR(S)	MODEL(S)	ADDITIONAL INFORMATION
2011 – 2015	Highlander HV

Some 2011 – 2015 model year Highlander HV vehicles may exhibit a condition of MIL "ON" with DTC(s) P2111 and/or P0A0F after a cold soak. Follow the Repair Procedure in this bulletin to address this condition.

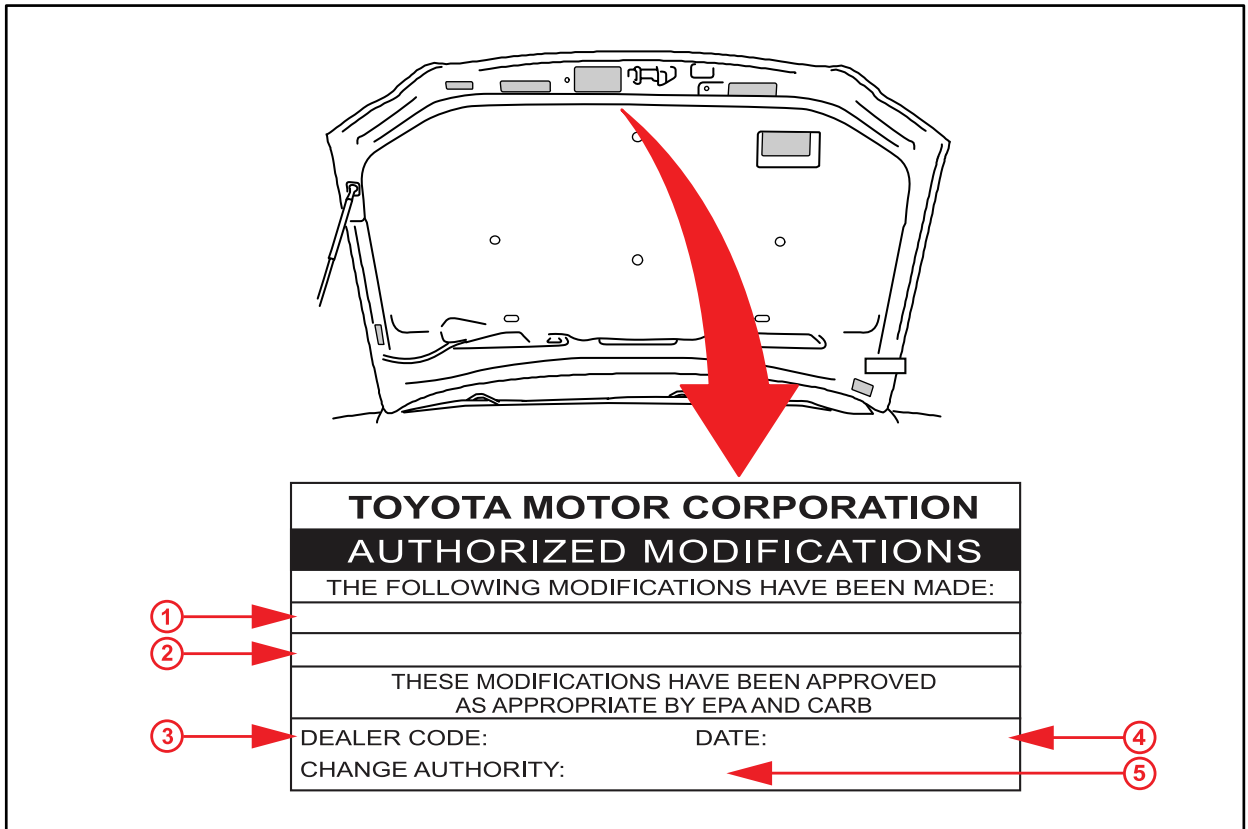
Figure 1. Location of Authorized Modifications Label on 2011 – 2015 Highlander HV

4. Check for the Authorized Modifications Label affixed to the vehicle in the location shown in Figure 1. Confirm if the ECM (PCM) calibrations have been updated. If the calibration IDs are NOT the latest calibrations — go to step 5.
