MIL "ON" - DTC P0087/P008700 - Fuel Rail / System Pressure Too Low

YEAR(S)	MODEL(S)	ADDITIONAL INFORMATION
2015	NX200T

Some 2015 model year NX200T vehicles equipped with 8AR-FTS engines may exhibit a MIL "ON" condition with Diagnostic Trouble Code (DTC) P0087 (Fuel Rail/System Pressure – Too Low). The Engine Control Module/ECM (SAE Term: Powertrain Control Module/PCM) logic has been modified to reduce the possibility of this condition occurring. Follow the Repair Procedure in this bulletin to address this condition.

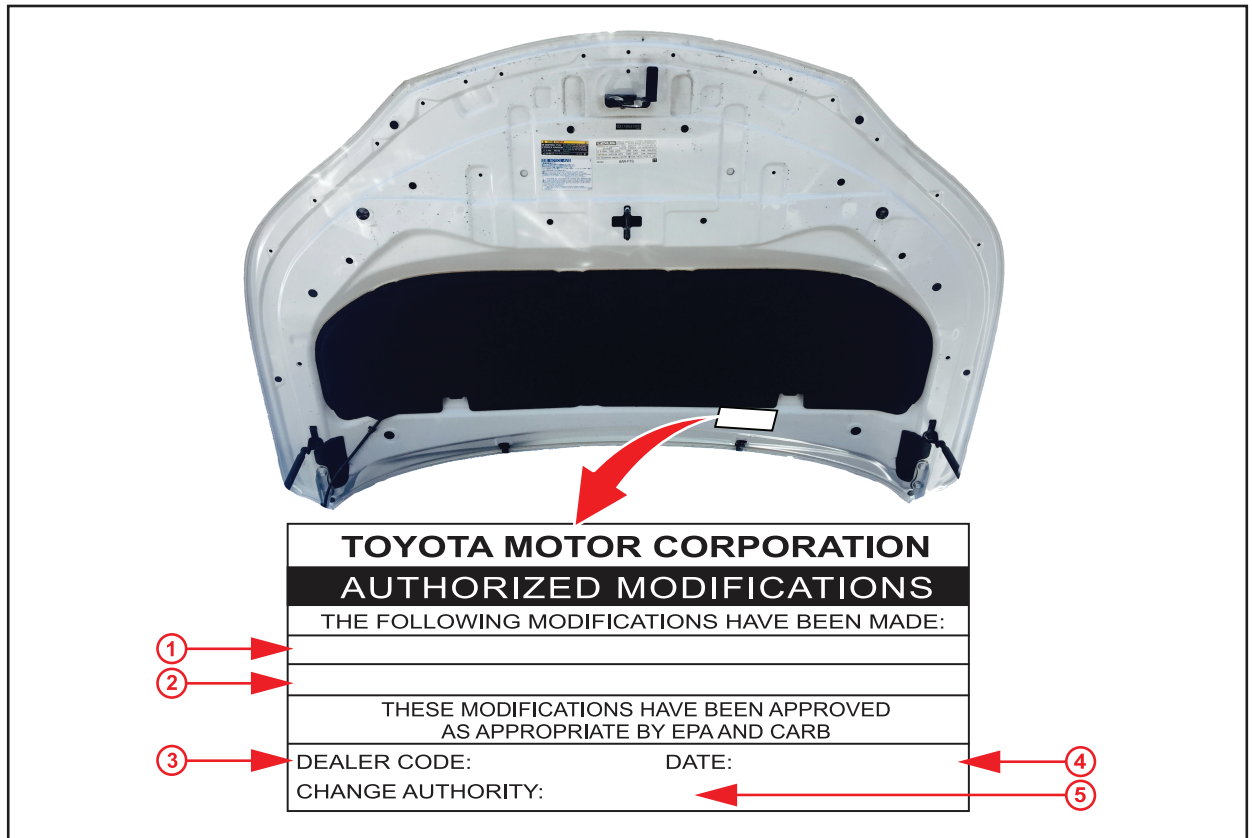
Figure 1. Location of Authorized Modifications Label on 2015 NX200T

2. Check for the Authorized Modifications Label affixed to the vehicle in the location shown in Figure 1 below. Confirm if the ECM (PCM) calibration has been updated. If the calibration ID listed is NOT the latest ECM (PCM) calibration — go to step 3.

4. Install the Authorized Modifications Label.
 - A. Using a permanent marker, enter the following information on the label:
 - ECM part number [*Refer to the **Parts Information** section for the **NEW PART NUMBER***]
 - Calibration ID(s) [*Refer to the **Calibration Information** section for the **NEW CALIBRATION ID***]
 - Dealer Code
 - Repair Date
 - Change Authority [***This bulletin number***]
 - B. Affix the Authorized Modifications Label to the vehicle at the location shown in Figure 1. The Authorized Modifications Label is available through the MDC, P/N 00451-00001-LBL.
5. Test drive the vehicle to confirm proper vehicle operation.
