MIL ON DTC P011B

Service Category Engine/Hybrid System

Section Engine Control

YEAR(S)	MODEL(S)	ADDITIONAL INFORMATION
2015	4Runner, Tacoma	VDS(s): BU5JR, JU4GN, KU4HN, LU4EN, MU4FN, TU4GN, UU4EN, ZU5JR Engine(s): 1GR Drive Type(s): 4WD, 2WD Plant Code(s): 5

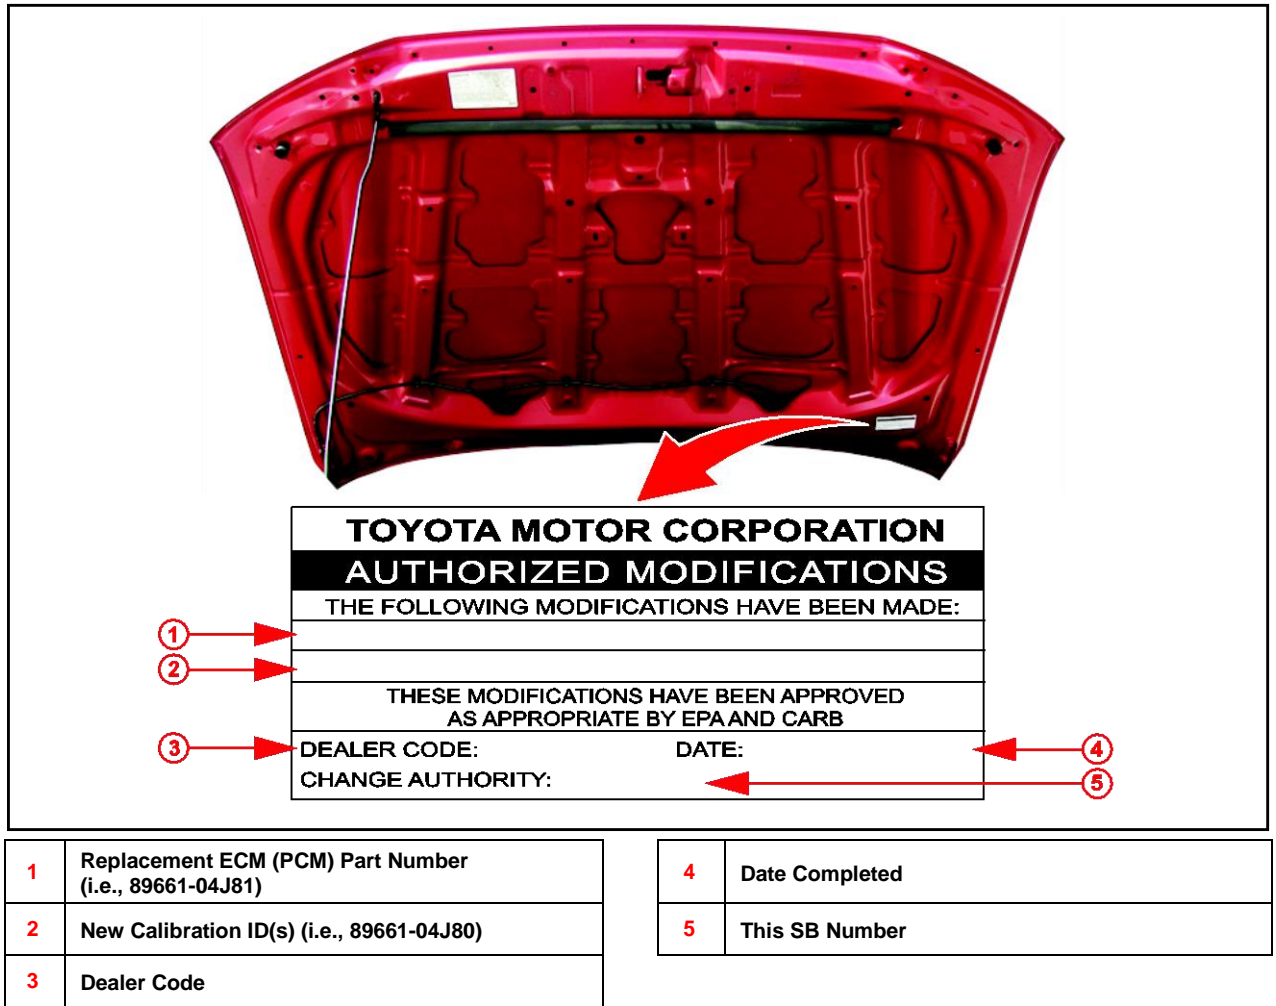
Figure 1. Location of Authorized Modifications Label on 2015 Tacoma and 4Runner

- **YES** — Go to step 2.
 - **NO** — This bulletin does NOT apply. Continue diagnosis using the applicable Repair Manual.
2. Check for an Authorized Modification Label affixed to the vehicle in the location shown in Figure 1. Confirm the ECM Cal ID has been updated. If the calibration ID listed is NOT the latest ECM Calibration or no label is found – go to step 3.

4. Install the Authorized Modifications Label.
 - A. Using a permanent marker, enter the following information on the label:
 - ECM part number [Refer to the **Parts Information** section for the **NEW PART NUMBER**]
 - Calibration ID(s) [Refer to the **Calibration Information** section for the **NEW CALIBRATION ID**]
 - Dealer Code
 - Repair Date
 - Change Authority [**This bulletin number**]
