Clearance Warning Sonar Abnormal Operation

Service Category Audio/Visual/Telematics

Section Park Assist/Monitoring

YEAR(S)	MODEL(S)	ADDITIONAL INFORMATION
2014 – 2015	Tundra

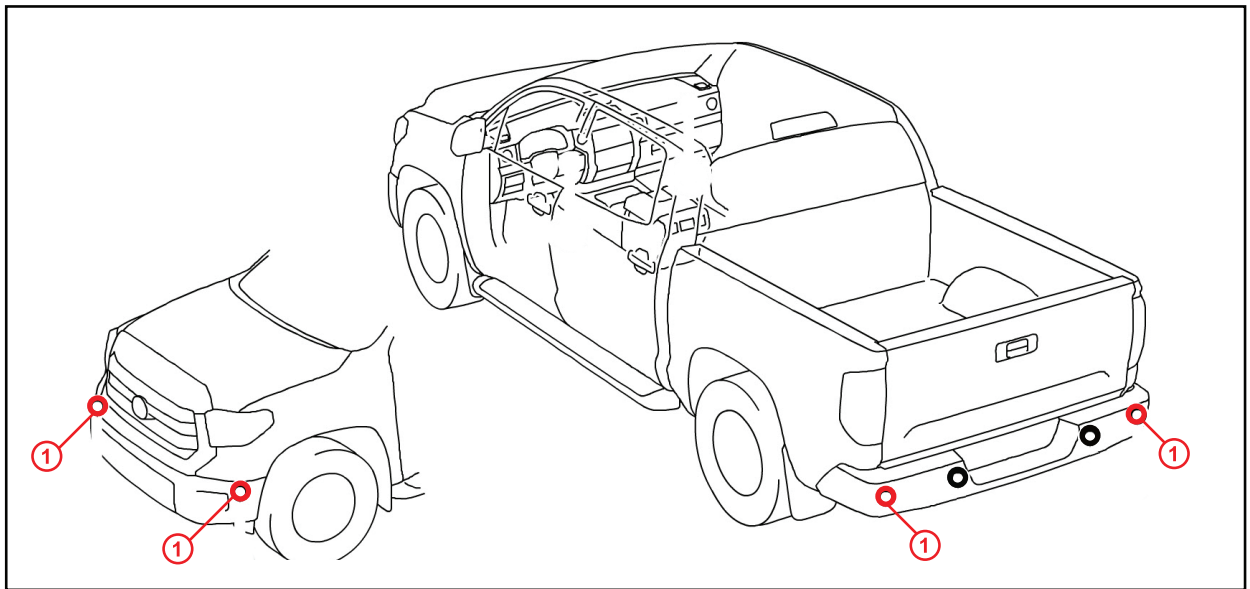
Figure 1.

1. Is the affected sensor mounted on a steel bumper?
 - **YES** — Continue to step 2.
 - **NO** — This bulletin does NOT apply. Continue diagnosis using the applicable Repair Manual.
2. Inspect the color of the sensor retainers on affected sensors in positions indicated below.

Retainer Color:

- **Black** — Continue to step 3.
- **White** — This bulletin does NOT apply. Continue diagnosis using the applicable Repair Manual.

1	Affected Sensors
----------	-------------------------

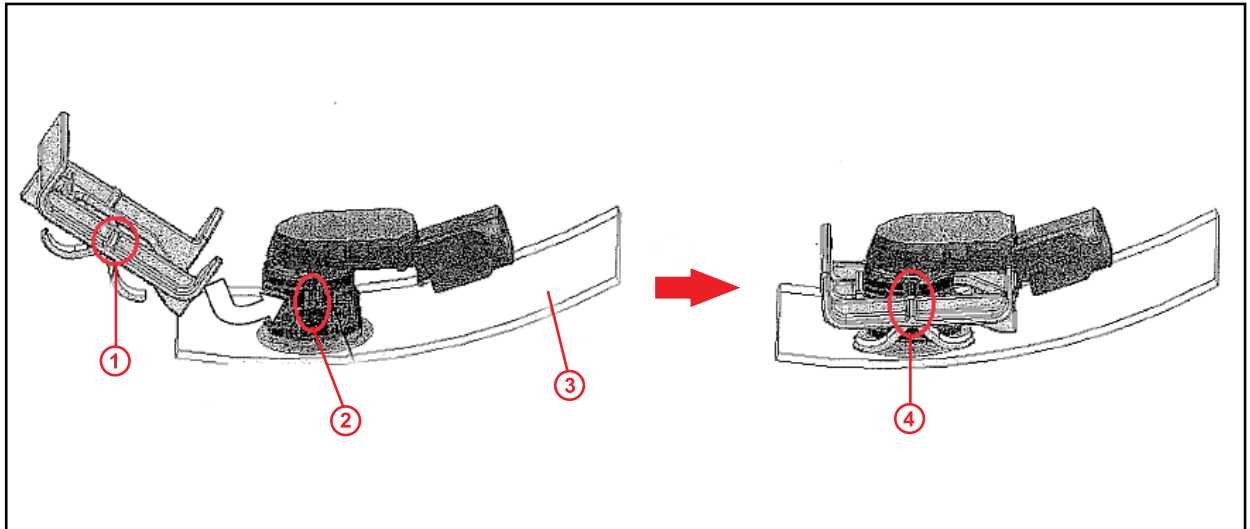
Figure 2.

1	Retainer
2	Sensor

3	Bumper
4	Teeth and Grooves Aligned

3. Replace the retainer of the affected sensors.
