Service Bulletin

Subject: Diagnostic Tip for Unable to Remove DC Vehicle Plug from Charge Port After Charging is Complete or Successfully Stopped, DTC P3014 Set

Models: 2014-2015 Chevrolet Spark EV

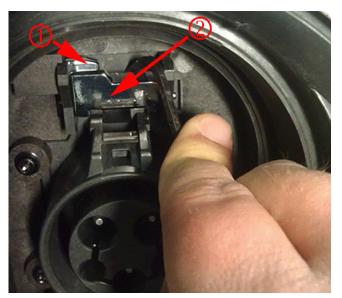
This condition may be caused by the DC charge port lock being stuck closed when the DC vehicle plug is engaged.

If the DC vehicle plug cannot be disconnected from the charge port due to the lock being stuck, perform the following steps to release the plug. Once the DC vehicle plug has been removed, the receptacle will need to be replaced.

- 1. Using the short end of a small allen wrench, push in the actuator rod located behind the latch.
- 2. Apply a minimum of 45 Y(10 lb) of force to the actuator rod.
