Service Bulletin

PRELIMINARY INFORMATION

Subject: Convertible Top Difficult to Latch Closed

Models: 2013-2015 Chevrolet Camaro Convertible

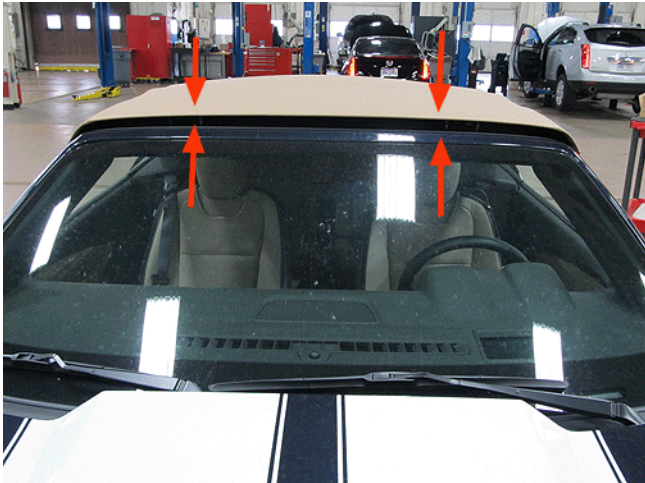
The cause of this condition may be incorrect positioning of the folding top in relation to the vehicle body. The graphics below show some examples of visual indicators of this top mis-alignment.

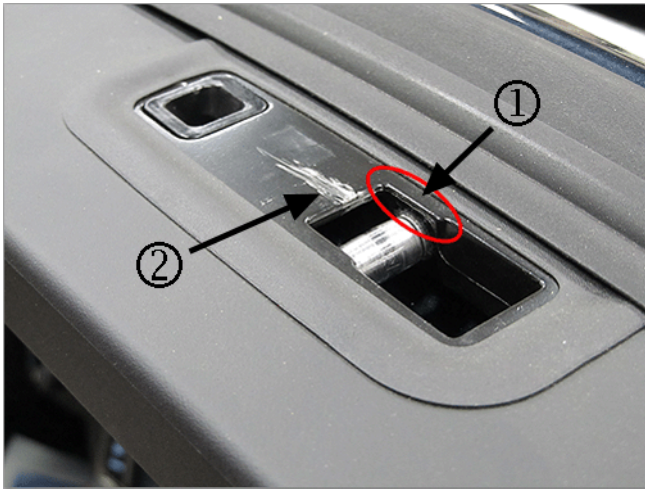
This driver side front striker shows latch impact marks at the forward edge (1) and the latch hook wear marks (2) too far forward.
