Service Bulletin

Subject: Diagnostic Tip for DTC P305F

Models: 2014-2015 Chevrolet Malibu
Equipped with Start/Stop System (RPO KL9)

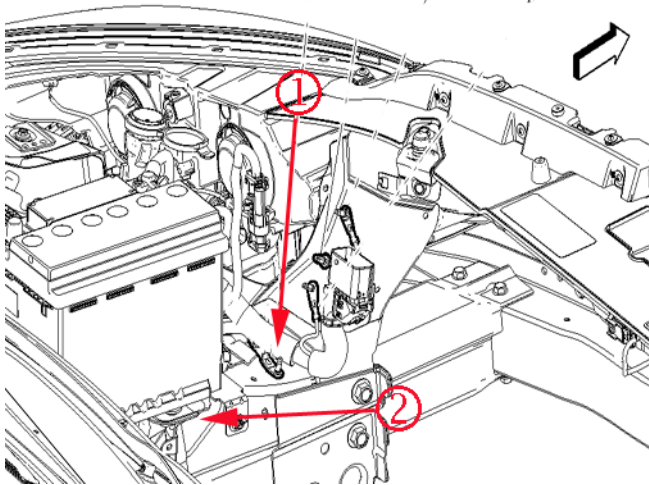
Technicians may find the diagnostic trouble code (DTC) P305F: Dual Battery Control Module Performance has been set in the Engine Control Module (ECM). There may be several different causes of this code setting and before any component replacements, please follow the recommendations below.

- Inspect for loose unsecured electrical ground at G103 (1).
- Verify the engine harness is not pinched underneath the main battery tray (2).
- Inspect both main and auxiliary battery cables for being secured.
- Perform the battery inspection/test in SI (Document ID# 3469663) to the auxiliary battery.
