Service Bulletin

Subject: Excessive Oil Consumption – Perform Oil Consumption Test and/or Install Piston and Piston Ring Kit

Models: 2010-2013 Buick LaCrosse
2011-2013 Buick Regal
2012-2013 Buick Verano
2010-2013 Chevrolet Equinox
2012-2013 Chevrolet Captiva, Orlando (Canada Only)
2010-2013 GMC Terrain
Equipped with 2.4L Engine (RPOs LAF, LEA)

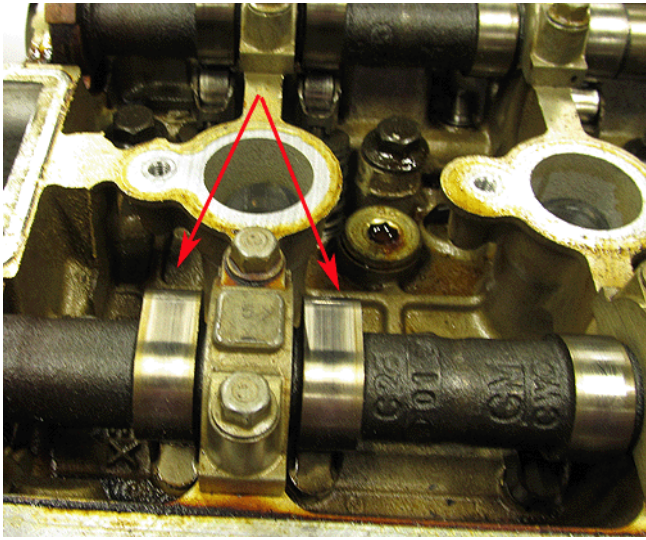
- Camshafts and roller follower will have wear markings. This is normal and do not need to be replaced (refer to picture above).

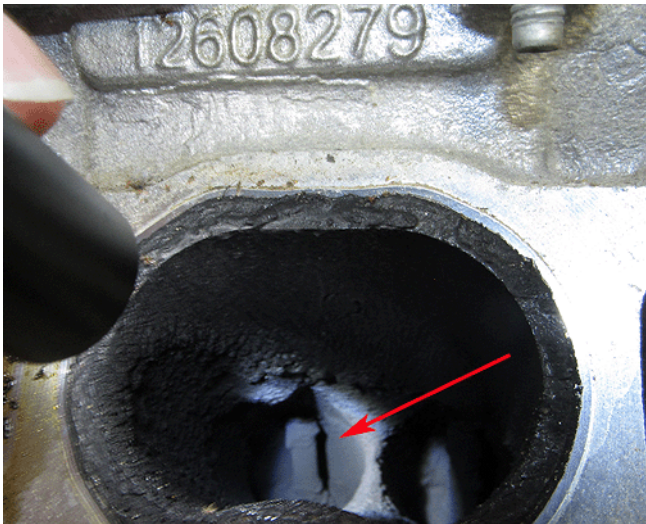
- Valves stems may have deposits build up on them. These deposits are characteristic of a direct inject engine. The valves stems do not need to be cleaned as they are not affecting engine performance (Refer to picture above).
- The oil pump does not need to be replaced as the low oil level operation did not damage the pump.
- The camshaft actuators do not need to be replaced at this time. The vehicle may have arrived with the engine knocking. If the oil level was 1 1/2 - 2 quarts low, it was the lack of oil causing the actuator noise.
- Rod bearings can be reused if there is not any excessive scoring. Some light wear marks are acceptable.
