Service Bulletin

Subject: Driver/Passenger Door and/or IP Accent Lighting – Light Bar (Pipe) Inoperative or Loses Intensity

Models: 2010-2015 Chevrolet Camaro
Equipped with Light Piped Door Trim (RPO FCR)

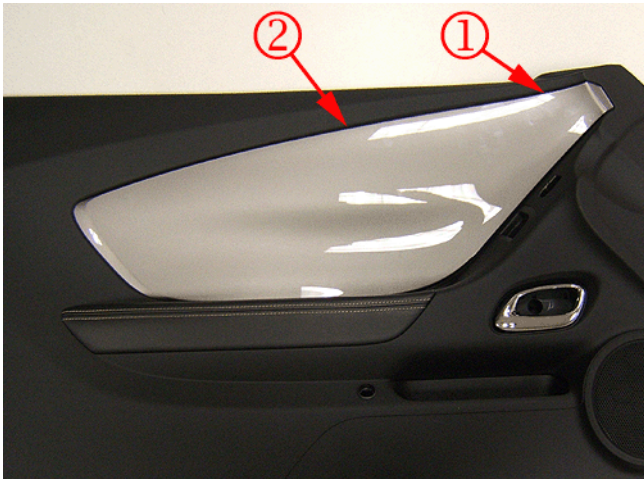
The normal operation of the door accent lighting is the light will be brightest at the rear of the door panel and gradually lose intensity until approximately 76mm (3in) (1) from the front edge of the trim panel. The lighting does not carry on to or across the instrument panel. If the light stops at the center of the door (2), proceed with this bulletin.

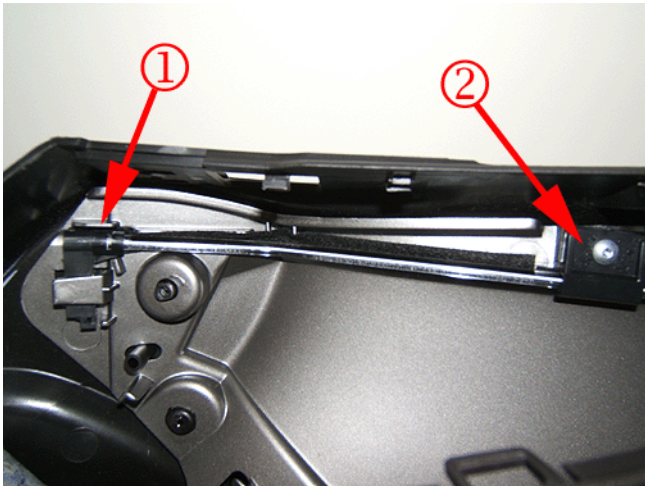
If the light stops at the center of the door, remove the trim panel and make sure the light bar (pipe):

1. Is in the channel
2. Has not dipped down
3. Is properly retained by the retaining clips (2)
4. End cap (1) is properly installed

To verify normal operation, apply 12 volts to the connector and make sure the light is brightest at the rear of the panel and gradually dims towards the front of the door panel.

If the light bar (pipe) is not illuminated the full length, is noticeably different from side to side or inoperative, replace the lamp-harness assembly. There are two different part numbers based on the illumination color of the lamp.
