# Service Bulletin

**Subject:** No GPS Signal Displayed or Navigation System Does Not Recognize Location of Vehicle

**Models:** 2015 Chevrolet Corvette  
Equipped with Vehicle Performance Data System (RPO UQT)

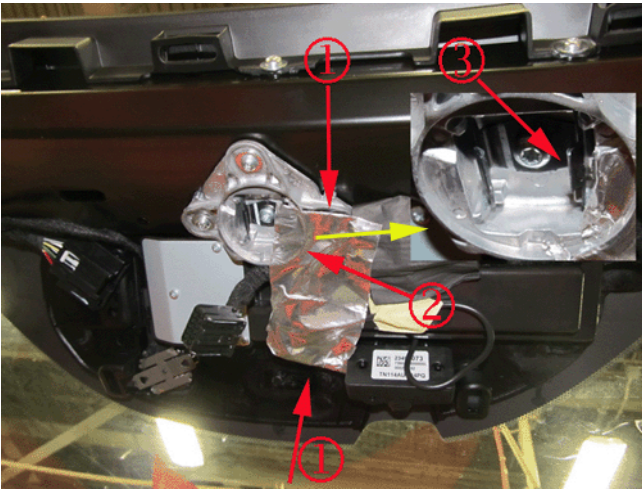
This may be caused by the software within the Vehicle Performance Data System and in certain cases the front view camera's coax cable may emit interference that reduces the satellite antenna's performance.

4. Cover the camera blue coax cable with the aluminum foil tape (1) as shown above.
  - The corner of the tape **MUST** cover the lip (2) of the inside rearview mirror bracket.
  - Ensure the aluminum foil tape does **NOT** contact the locking tabs (3) for the rearview mirror in the bracket.
