Service Bulletin

Subject: Diagnostic Tips for No Forward Movement, DTC P0777, DTC P2723

Models: 2015 Chevrolet Colorado
2015 GMC Canyon
Equipped with 6L50 Automatic Transmission (RPO MYB)

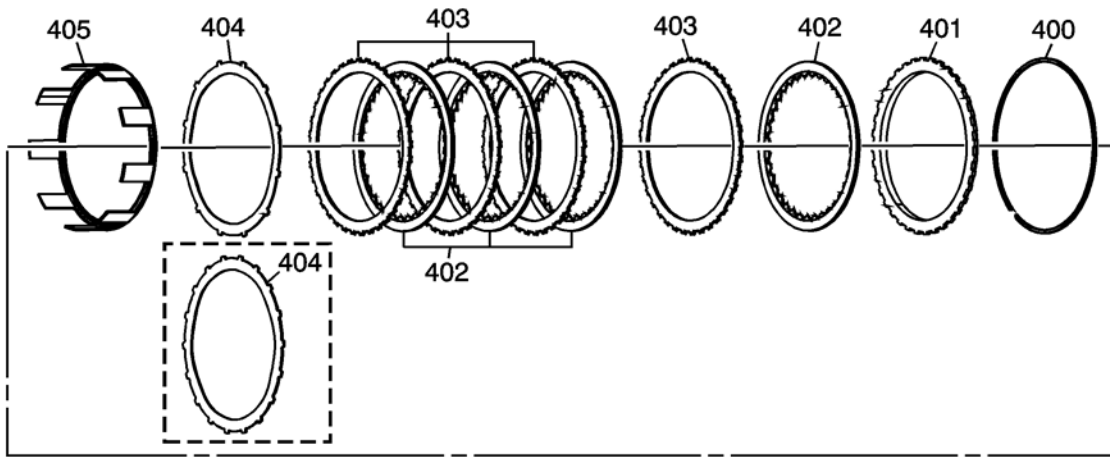
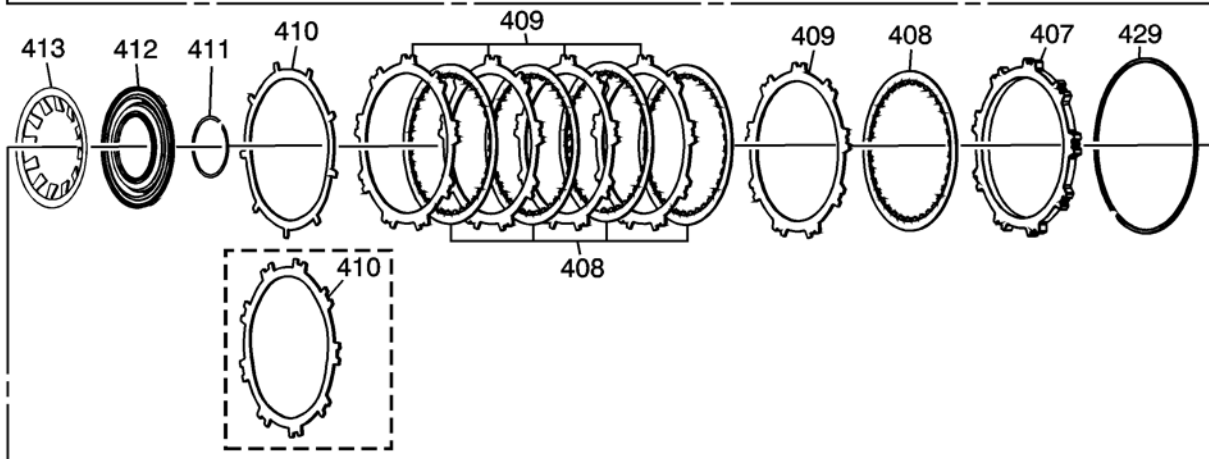
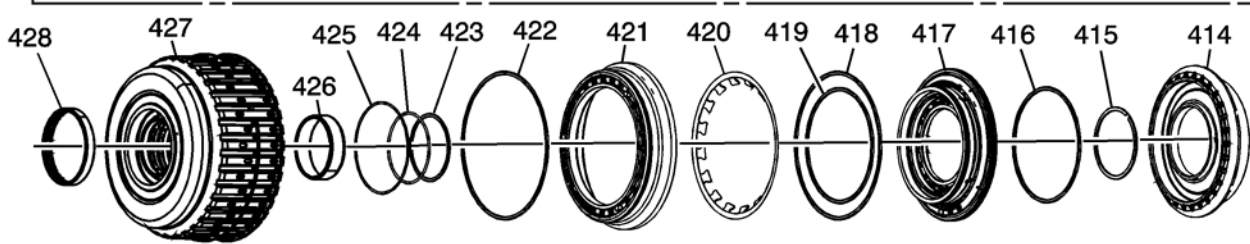
This condition may be caused by the 1-2-3-4 Clutch Backing Plate Retaining Ring (429) being out of the groove. Disassemble the 1-2-3-4 and 3-5-R clutch assembly to inspect this retaining ring. Also inspect all the seal rings used in this clutch assembly (416, 418, 419, 422-425) to make sure they are not cut or damaged.

If the retaining ring (429) is found to be out of the groove, be sure to replace the 1-2-3-4 and 3-5 Reverse Clutch Housing Assembly (427) and the retaining ring (429).
