# Service Bulletin

**Subject:** Floor/Carpet Wet at Front Passenger Side Under Dash, or at Any Front/Rear Footwell Area

**Models:** 2011-2015 Chevrolet Caprice PPV

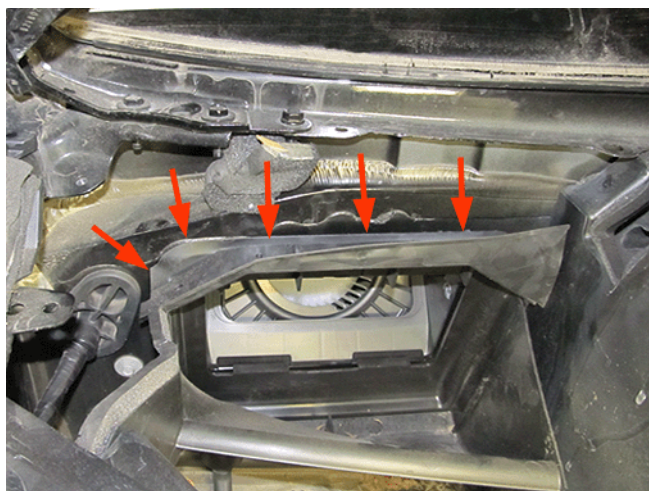
- Water intrusion in the seam (1) between the HVAC case and the cowl.

3. Apply windshield urethane, such as \*Kent Industries Speed Set Windshield Sealant P/N P10545, or equivalent, to the seam to seal the top of the HVAC case to the cowl.

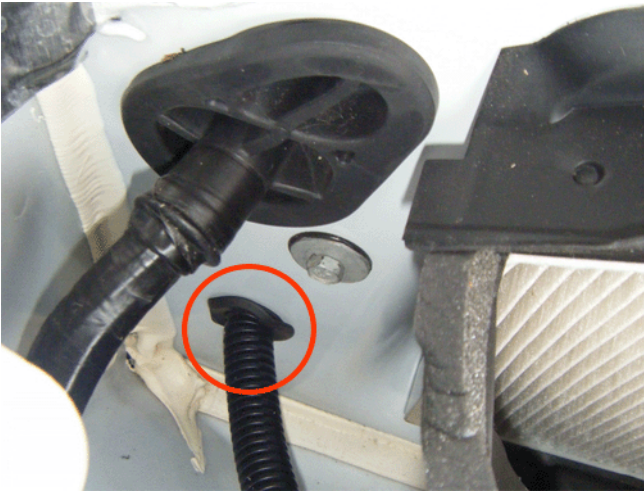
- For some police equipped vehicles, water may run on the wire harness exiting the HVAC case, then follow along the conduit into a grommet/hole (shown circled in the graphic above) in the cowl, and finally run into the vehicle interior.

- 5.3. Apply windshield urethane to the cowl and grommet to seal the wire harness to the hole through the cowl.
6. Reinstall the upper and lower air inlet grille panels. Refer to Air Inlet Grille Panel Replacement (Lower Panel) in SI.

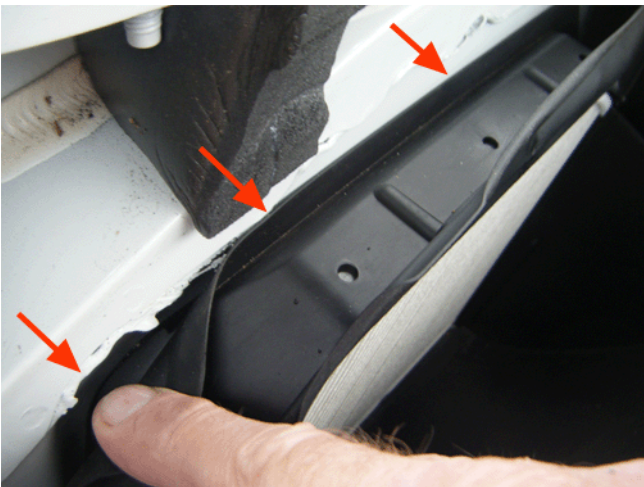
2. Inspect the seam at the top of the HVAC case, where the case sits against the cowl. The seam is commonly not sealed in this area and water coming off the windshield may find a path behind the case and leak into several places in the interior under the dash.

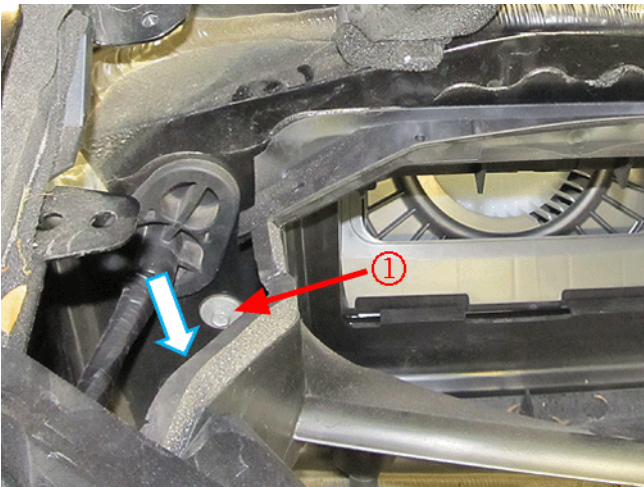
4. Inspect the cowl area outside the HVAC case for the possible existence of a wiring harness associated with certain police equipped vehicles. If equipped, the grommet/hole location for the harness will be just below the bolt (1) shown in the graphic above.

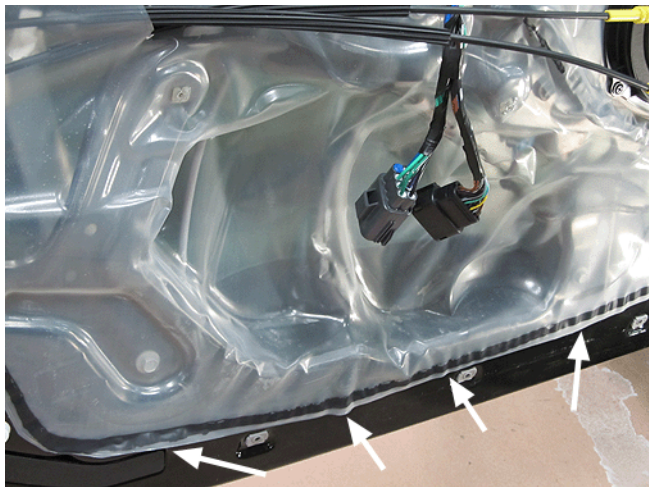
The cause of this condition may be that water, normally being channeled through a side door, may bypass an improperly sealed water deflector and create a leak path into the vehicle. Because of the increased mirror/window switch wiring harness content, this condition most commonly occurs at the driver door, but may occur at any front or rear side door.

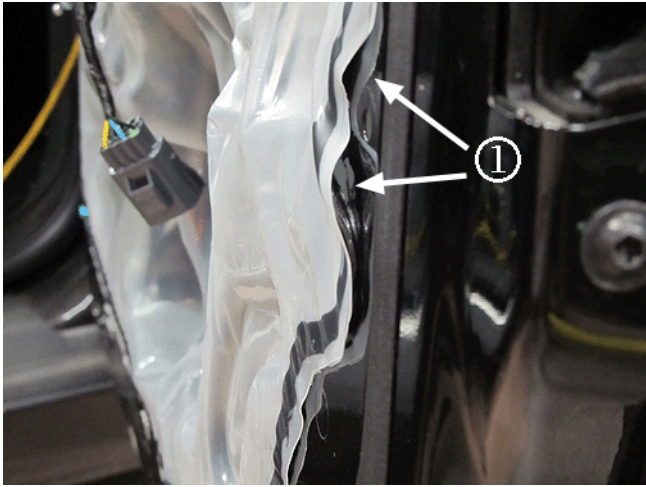
2. Inspect the door water deflector for any puckers/gaps (1) where the butyl adhesive may have pulled away from the inner door surface.

3. If puckers or gaps are evident, pull the water deflector away from the sheet metal to release the butyl adhesive along the bottom and lower corners.
4. Apply a bead of \*Kent Automotive Windshield Butyl Tape P/N P20230. or equivalent, above the existing butyl on the water deflector.

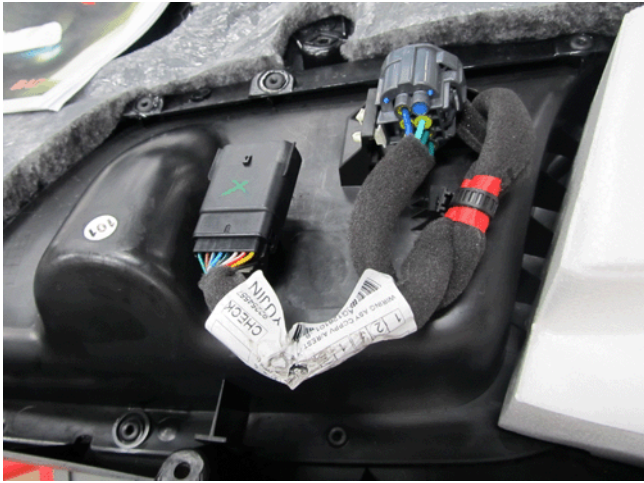
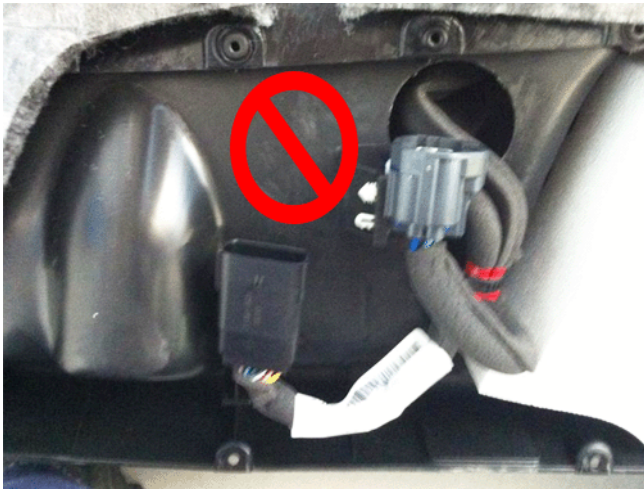
**Important:** The correct harness routing is shown in the first graphic above. An example of an incorrect routing is shown in the second graphic.

- 8.1. Ensure the harnesses are routed as shown in the first graphic above. It may be necessary to unclip the grey connector and reroute the one harness underneath the other to achieve this.

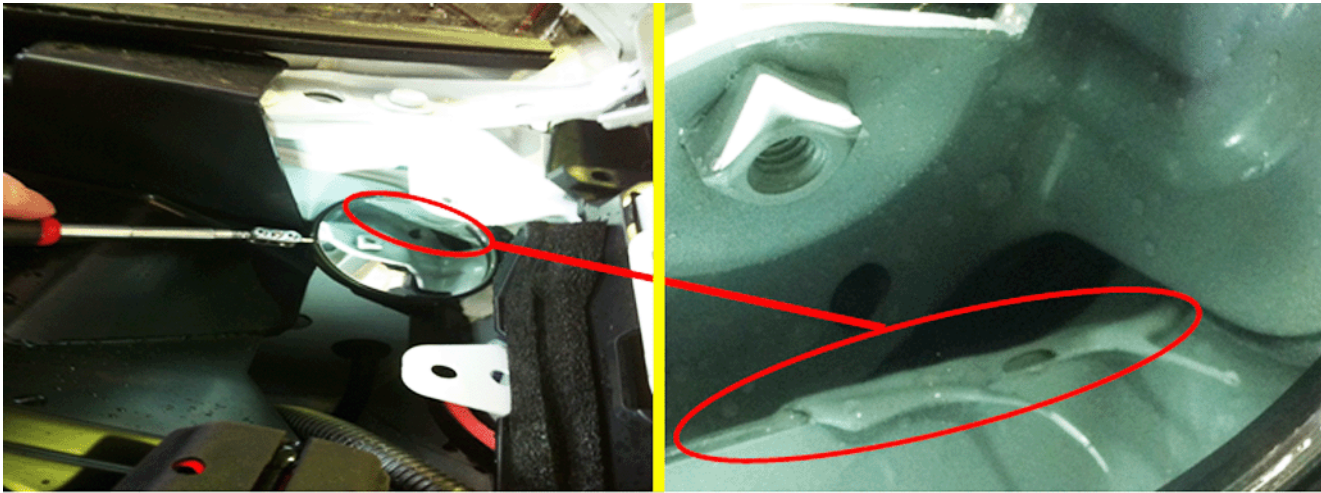
The cause of this condition may be an improperly sealed body seam at the left front cowl/plenum area, behind the wiper motor. Water can enter this seam, flow down the A-pillar and front door sill and may puddle in the rear footwell.

- 4.1. Use an inspection mirror to view a section of the seam underneath the cowl brace.
- 4.2. Apply water from a hose directly at the seam.
- 4.3. If leaking, water droplets will be seen dripping down the A-pillar. It may take at least three minutes for the water droplets to show.
