Service Bulletin

Subject: Diagnostic Tips for Oil Leak from Timing Belt Area

Models: 2014-2015 Chevrolet Cruze, Sonic, Trax
Equipped with 1.8L Engine (RPOs LUW, LWE, 2HO)

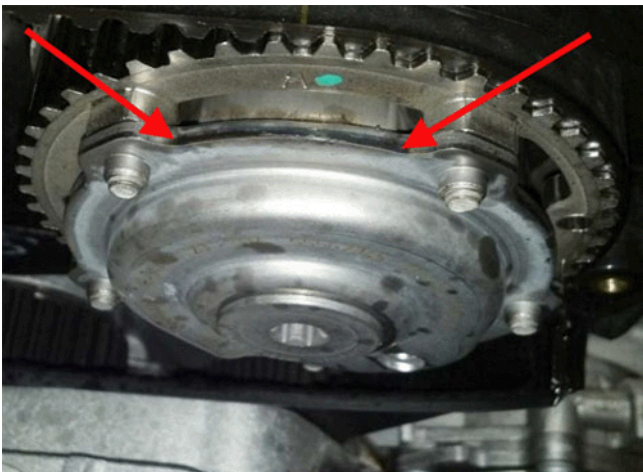
Remove the timing belt upper front cover and inspect for signs of engine oil in the camshaft sprocket and timing belt area. This is a dry area and should not show signs of oil residue. Refer to Timing Belt Upper Front Cover Removal in SI.

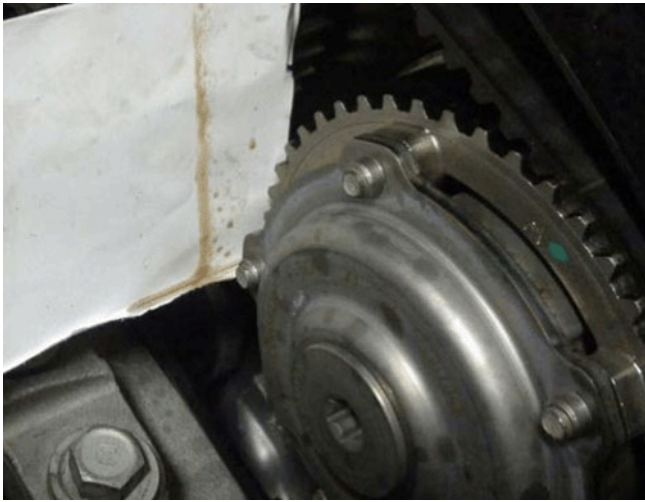
Clean any residual oil from the camshaft sprockets. Using white paper, run the engine off idle at 2000 RPM to check for oil being ejected from either the intake or exhaust camshaft sprocket.

It may require you hold the paper near each sprocket to identify which sprocket is leaking. The oil shown on the paper in the picture is after approximately 30 seconds of operation at 2000 RPM. The arrows indicate the area of the potential leak.

If oil is ejected from the camshaft sprocket, replace the leaking sprocket and the timing belt.
