Service Bulletin

Subject: Diagnostic Tip for DTC P0336: Crankshaft Position Sensor Performance

Models: 2015 Chevrolet Spark
Equipped with 1.2L Engine (RPO LL0)
Built Prior to VIN Breakpoint FC747743

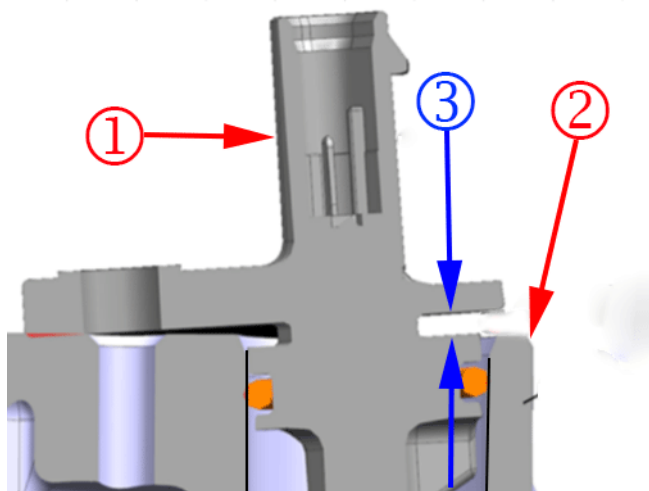
This may be caused by the crankshaft position sensor not being fully seated in the bore of the transmission case, creating an excessive space between the crankshaft position sensor and the automatic transmission flex plate.

1. Crankshaft Position Sensor

2. Transmission Case

3. Gap

2. Inspect the gap as illustrated above.

- Correct gap is less than 0.35 mm (0.01378 in).

- Incorrect gap is 0.35 mm (0.01378 in) or more.
3. If the gap is correct, wiggle the connector to verify if the connector is secured. If the connector is secured, continue diagnosis. Refer to the diagnostic code P0336 in SI. If the connector is not secure, secure connector and then skip to step 5.

4. If the gap is incorrect, remove and reinstall the crankshaft position sensor.
Tighten: Tighten the bolt to 10 Y (89 lb in).
 5. Reinstall the air cleaner assembly. Refer to the Air Cleaner Assembly Replacement in SI.
