Service Bulletin

PRELIMINARY INFORMATION

Subject: Intermittent Gauges Drop and/or Radio and HVAC Displays Blank Out When Passenger Seat is Occupied

Models: 2013 Chevrolet Malibu
Built Prior to March 14, 2014

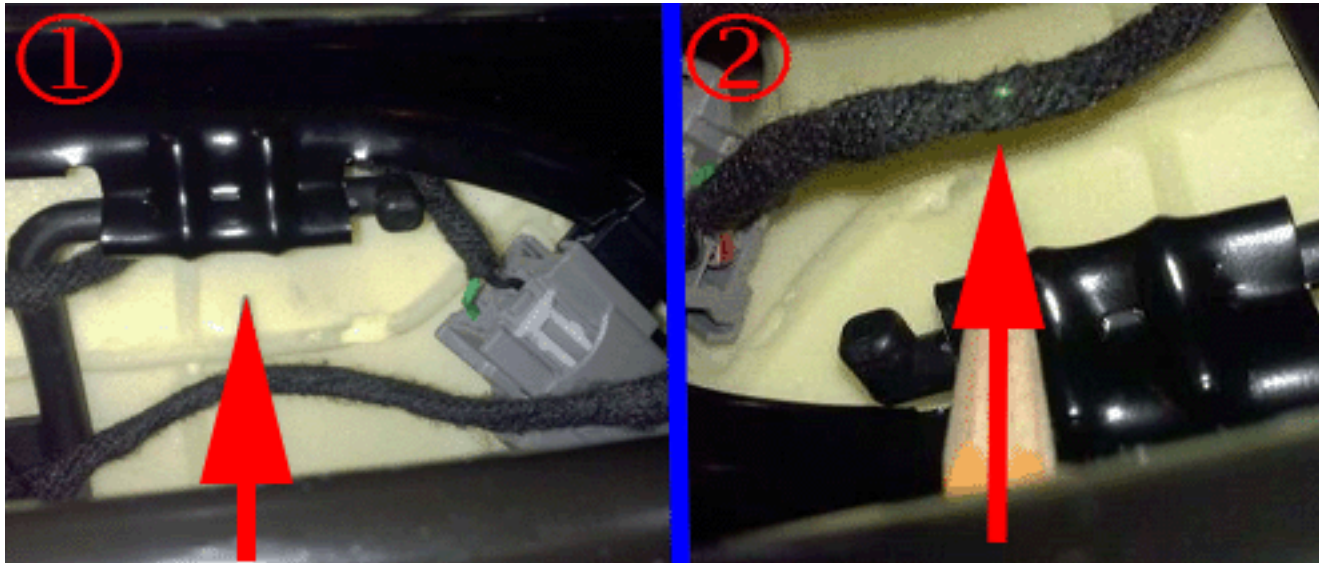
This may be caused by a chaffed wire or short to ground in circuit 5060 from X320 cavity 7 to the Passenger Presence Sensor.

1. Before Harness Removed from Seat Frame

2. After Harness Removed from Seat Frame
