Service Bulletin

PRELIMINARY INFORMATION

Subject: Engineering Information – Battery Saver Active Message Displayed on DIC, Drive Motor Generator Belt Broken, DTC P1A6F or P0A90 May be Set

Models: 2013-2014 Buick LaCrosse, Regal
2013-2014 Chevrolet Malibu
Equipped with eAssist (RPO LUK)

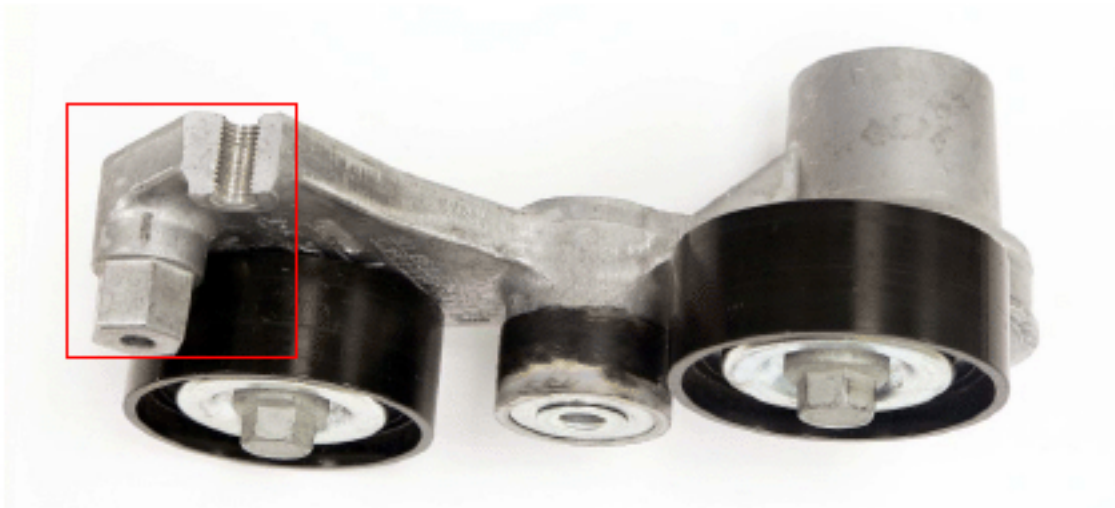
Further inspection may reveal that the drive motor generator unit (MGU) belt is broken or the tensioner is broken at the hydraulic tensioner attachment boss (shown below).

If you encounter a vehicle with the above concern, inspect the MGU belt and tensioner. If the belt looks like it was cleanly snapped or if the tensioner is broken at the attachment boss (shown above), contact the engineer listed below for further instructions.
