Service Bulletin

Subject: Blank Display, NAV Screen Audio Content is Unavailable via Speech Recognition, Display Screen is Stuck on Incoming Call View After Phone Call Finished, Rear View Camera Display Blank, USB Issues/Bluetooth/Favorite Bar/Voice, iPod Unable to Detect via USB, Recognition Concerns, XM Speech Recognition Inoperative, Traffic Messages, Clock Display

Models: 2015 Buick LaCrosse, Regal
2015 Cadillac ATS, CTS Sedan (VIN A), Escalade Models (RPO AVF), SRX, XTS
2015 Chevrolet Colorado, Corvette, Impala (VIN 1), Silverado 1500, Silverado 2500/3500 (RPO AVF), Suburban (RPO AVF), Tahoe (RPO AVF)
2015 GMC Canyon, Sierra 1500, Sierra 2500/3500 (RPO AVF), Yukon Models (RPO AVF)
Equipped with RPOs RAO (SRX Only), RAO + UA3/UY4, IO4, IO5, IO6

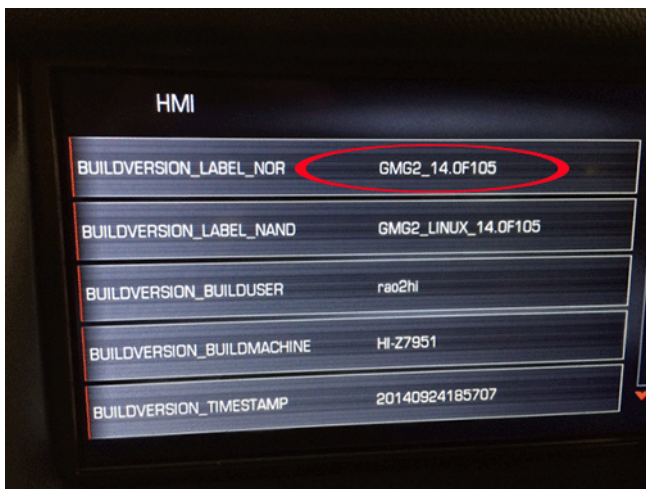
Before updating software, check the HMI build version. The HMI build version label should be earlier than GMG2_14.OF105.

Caution: If the software version is earlier than GMG2_14.OF105, proceed with this PI. If the version is the same or later, damage to the HMI module may occur. DO NOT PROCEED WITH THIS PI.

Note: The last 3 numbers will increase as the software gets updated. Those are the numbers to check when verifying software version.

An updated software calibration has been released to address the above conditions. Update the HMI Module using a **USB FLASH DRIVE** and the Service Programming System (SPS) with the files available on TIS2WEB. Refer to the SPS procedures in SI.
