Service Bulletin

PRELIMINARY INFORMATION

Subject: Roof Panel Joint Finish Molding (Ditch Molding) Loose or Lifted in Areas

Models: 2014-2015 GMC Acadia

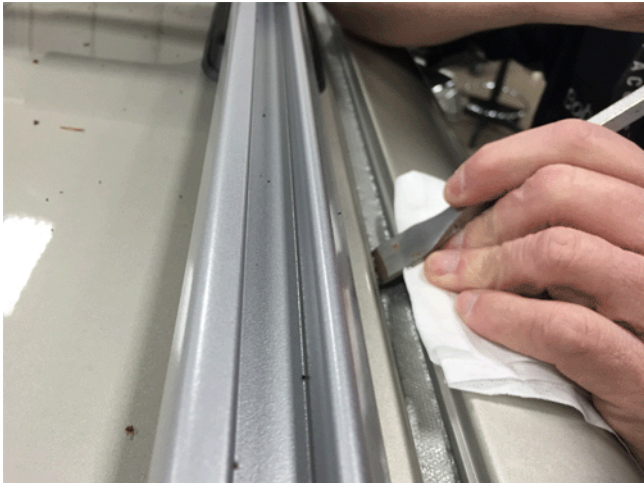
Some customers may comment that the roof panel finish molding (ditch molding) has come loose or lifted in areas. This may be caused by wrinkles in the sealant used to secure the body panels.

1. Remove the affected ditch molding. Refer to Roof Panel Joint Finish Molding Replacement in SI.
Important: Be careful to not damage the molding when removing.
2. With the molding removed, visually inspect for wrinkles greater than 1 mm (0.04 in) in the sealant running along the location of the molding.
