Service Bulletin

Subject: Inspect XM/Cellular Mobile Phone/OnStar® Antenna for Looseness or Damage, XM/Cellular/OnStar® Reception Performance Degraded, Rattle/Flutter/Squeak Noise, Wind Noise/Whistle at Highway Speeds, Water Leak on Headliner at Sunvisor

Models: 2010-2015 Cadillac Escalade Models
2010-2013 Chevrolet Avalanche
2010-2015 Chevrolet Silverado, Suburban, Tahoe
2010-2015 GMC Sierra, Yukon Models

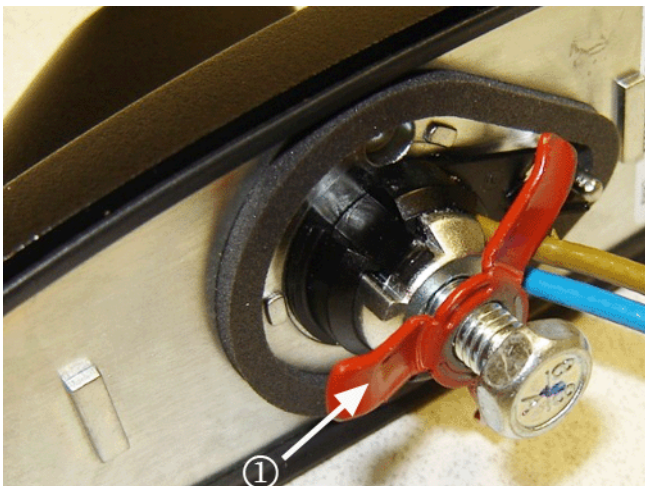
The cause of this condition may be looseness and/or damage of the XM/cellular mobile phone/OnStar® antenna, which may affect the grounding of the antenna and may allow a rattle/wind noise at highway speeds and/or a water leak.

Though difficult to detect evidence of impact damage, upon inspection of the antennas returned in warranty, there is a likelihood this damage occurred during vehicle transportation to dealerships. The result of impact damage is most often to the underside retainer (1), which is found to be bent backward or otherwise damaged and no longer provides proper retention.

If the antenna is loose or damaged, it must be replaced. Refer to Cellular Communications/Digital Radio Antenna Replacement in SI.

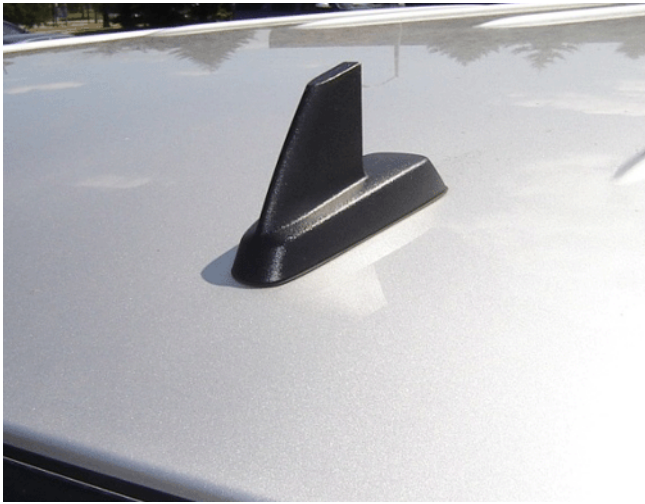
Grasp and physically inspect the XM, cellular mobile phone, and/or OnStar® antenna for looseness and/or damage. If the antenna is mounted securely and exhibits no signs of physical damage, follow regular diagnostic information in SI to address any customer concern.
