Service Bulletin

Subject: Oil Leak at Rear of Engine

Models: 2015 Chevrolet Cruze, Sonic
Equipped with 1.4L Engine (RPO LUV)
Built After VIN Breakpoint F7182003 (Cruze) and F4169885 (Sonic)

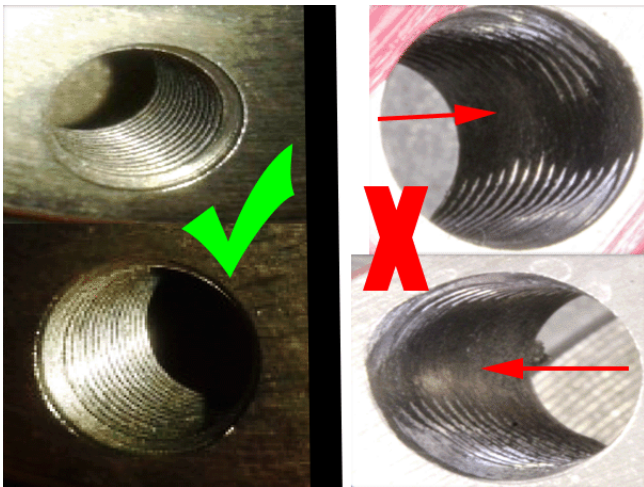
2. Inspect the 6 crankshaft threaded bores as illustrated above.

- Threads on the left of the image have the complete circumference of threads and is **NOT** the root cause of the oil leak.

- Threads on right of the image have the partially, not complete circumference of threads and is most likely the root cause of the oil leak.

Note: If the threads are incorrect, there will be oil present on the bolts' threads and mating surface to the flywheel or flex plate.

3. If all of the threads in the bore are correct, do not use this procedure because this is not the root cause of the oil leak. Continue diagnoses of the origins of the oil leak.

4. If the threads are incorrect, clean the affected threads with M 9x1 mm thread cutter.

Important: In order to avoid engine contamination, do **NOT** go past the depth of 20 mm with the cutter.

Note: The thread cutter will not correct the lack of threads in the bore. It is only used to clean the remaining bolt thread lock in the bore to allow for a better sealer adhesion.

5. Clean all 6 crankshaft bores with Brake Cleaner or equivalent.
