Service Bulletin

PRELIMINARY INFORMATION

Subject: Water Leak on Driver and/or Passenger Side Floor

Models: 2014-2015 Chevrolet Malibu
Built at Fairfax (VIN Code F) and Prior to VIN Breakpoint FF262445

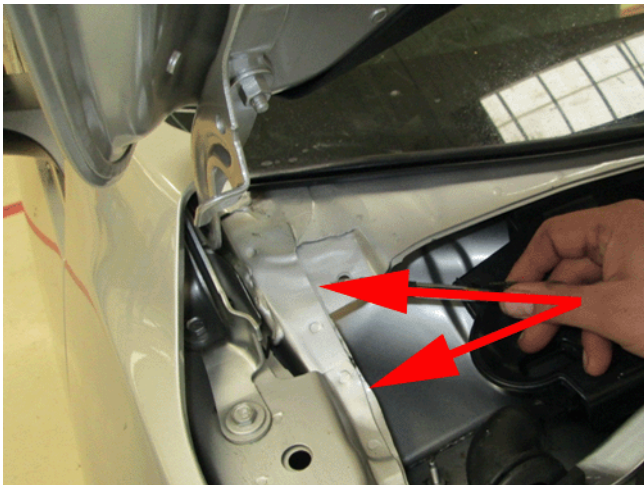
This may be caused by a void in the sealer that could allow water to pass from the body structure into the driver/passenger compartment area.

3. With the air inlet panel removed, visually inspect for voids in the body sealer on the affected side in areas illustrated above.
4. If there are voids found in the body sealer, apply high tech clear seam sealer, Kent Industries P/N P10200*, to the affected areas.
5. After all voids are filled, perform a waterleak test to verify the condition is corrected. Refer to Waterleak Test Preparation in SI.
