# Service Bulletin

## PRELIMINARY INFORMATION

**Subject:** Steam/Vapor Coming from Front Grille or Radiator Area, Engine Runs Rough or Stalls, DTC P0506 Set

**Models:** 2014 Chevrolet Impala (VIN 1)

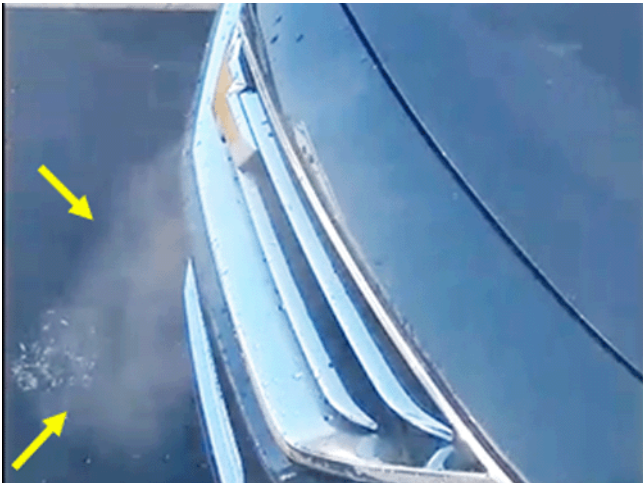
Some customers may comment that steam is coming from the front grille at idle, or on seeing vapor coming from the radiator after car washes.

The cause of this condition may be the result of rain or car wash runoff water reaching the condenser, radiator and fan module (CRFM) where it can be vaporized and, with the right weather, can become visible condensate.

Apply BRS tape to the front compartment front sight shield front lip and replace the radiator air upper baffle and deflector following the procedure below.
