Service Bulletin

PRELIMINARY INFORMATION

Subject: Intermittently Key Will Not Rotate in Door or Ignition Lock Cylinder

Models: 2008-2016 GM Passenger Cars and Trucks
Equipped with a "Side Mill" Key

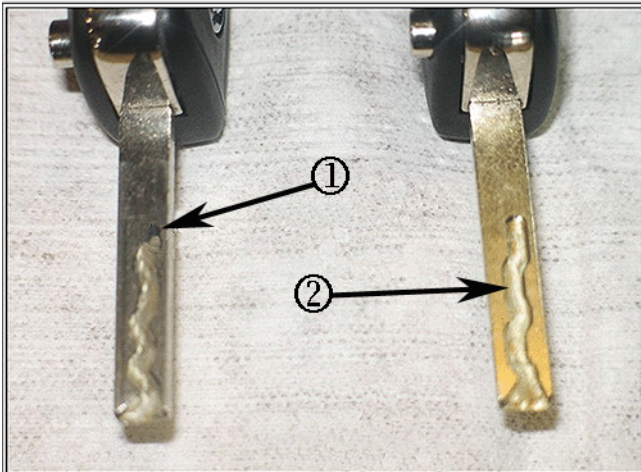
The above vehicles use a new style of key called a "side mill" key. Debris (1) may build up in the key groove preventing full insertion of the key. A properly cleaned key (2) will be free of any debris.

Important: Some side mill keys have the cut along the keys edge as opposed to the central cut shown in the photograph. Keys with either physical appearance may collect debris along the slot.

Clean the debris from the groove with a fine wire brush and a soft cloth.
