Service Bulletin

PRELIMINARY INFORMATION

Subject: Wind Noise from Accessory Roof Cross Rails

Models: 2010-2016 Buick Enclave
2015 Cadillac Escalade
2010-2016 Chevrolet Traverse
2015 Chevrolet Suburban, Tahoe
2010-2016 GMC Acadia
2015 GMC Yukon, Yukon XL
Equipped with RPO 5VJ, 549, VQP or VQQ

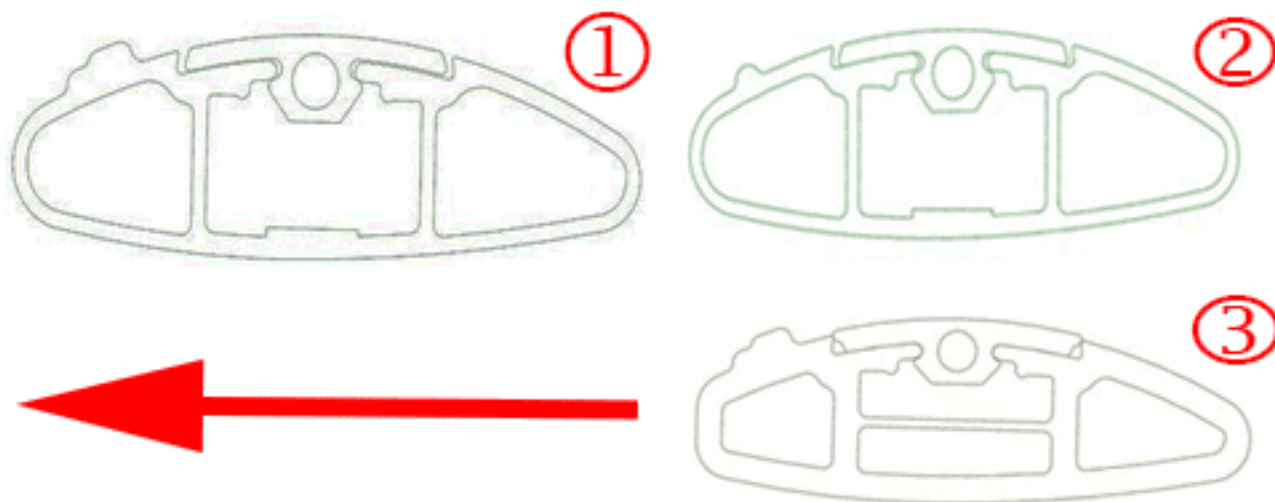
1. *Traverse & Acadia Cross Rail Direction*
 2. *Enclave Cross Rail Direction*
 3. *Escalade, Suburban, Tahoe, and Yukon Cross Rail Direction*
 3. Verify that the cross rails are installed properly and facing the correct direction as shown in the above illustration with the correct forward direction shown with the arrow.
 - If the rails are installed incorrectly, remove and install in the correct direction.
 4. Check for excessive movement in the rubber strips located on the top of the cross rail. If there is excessive movement in the strips, replace the strips.
 5. If the noise is still present after the replacement of the rubber strips, replace the accessory cross rails.
- Important:** Only replace the cross rails if the noise is still present after Step 4.
