Service Bulletin

PRELIMINARY INFORMATION

Subject: Air Bag Indicator Illuminated with DTC B0012 or B0013

Models: 2015 Cadillac ATS, CTS Sedan (VIN A)
Built Between August 1 through October 1, 2014

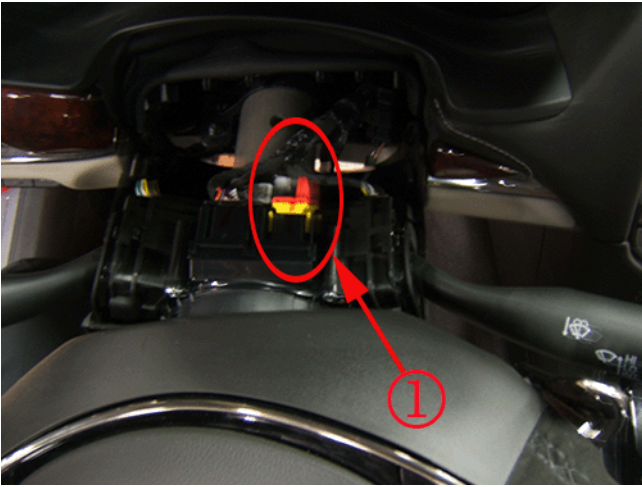
This condition may be caused by poor terminal tension in X85 Steering Wheel Air Bag Coil X3 connector.

3. Disconnect the X85 Steering Wheel Air Bag Coil X3 connector (1), illustrated above.
 - Disengage the connector position assurance (CPA).
 - Disconnect the X3 connector.
4. Test probe each terminal for poor tension with J-35616-65B (LT BU).
5. If the terminal tension is within specification, continue diagnoses. Refer to the diagnostic trouble code (DTC) B0012 or B0013 in SI.
6. If one or more terminal tension is found to be poor, replace the connector with service connector P/N 13580115 with the next steps of this procedure.
7. Remove the steering column lower trim panel. Refer to the Steering Column Lower Trim Cover Replacement in SI.
8. Remove the instrument panel knee bolster deflector. Refer to the Driver Knee Bolster Reinforcement Replacement in SI.
