Service Bulletin

Subject: Information on Front Engine Mount Service Recommendation

Models: 2008-2015 Buick Enclave
2009-2015 Chevrolet Traverse
2007-2015 GMC Acadia
2007-2010 Saturn OUTLOOK

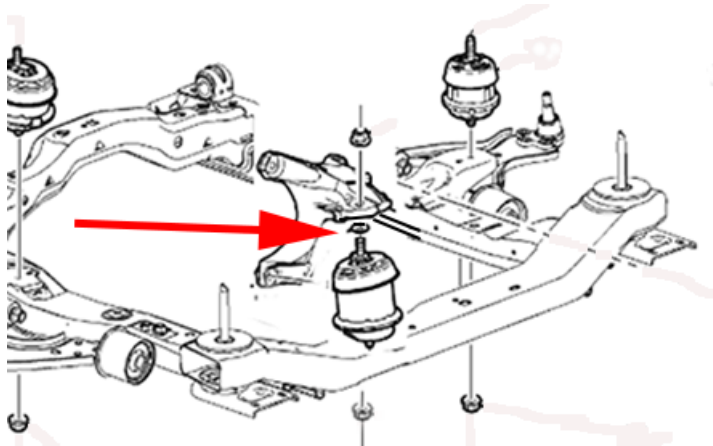
During normal operation of the vehicle where frequent hot ambient temperatures are experienced, the heat generated from the powertrain may be transferred into the front engine mount from the mount bracket and may weaken the rubber material in the mount.

In addition to replacing the front engine mount nuts, General Motors recommends the installation of a newly released washer, P/N 22925178, underneath the front engine mount bracket, on top of the engine mount as illustrated above. This service recommendation will help prevent the weakening of the rubber material in the mount by reducing the transfer of the excessive heat.
