Service Bulletin

Subject: Headliner Wet/Water Leak from Front or Rear Sunroof Glass (Replace Sunroof Window Weatherstrip/Seal)

Models: 2008-2016 Buick Enclave
2009-2016 Chevrolet Traverse
2007-2016 GMC Acadia
2007-2010 Saturn OUTLOOK

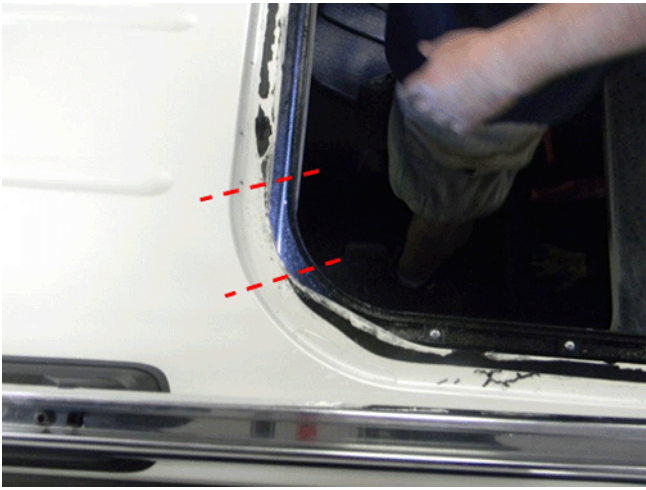
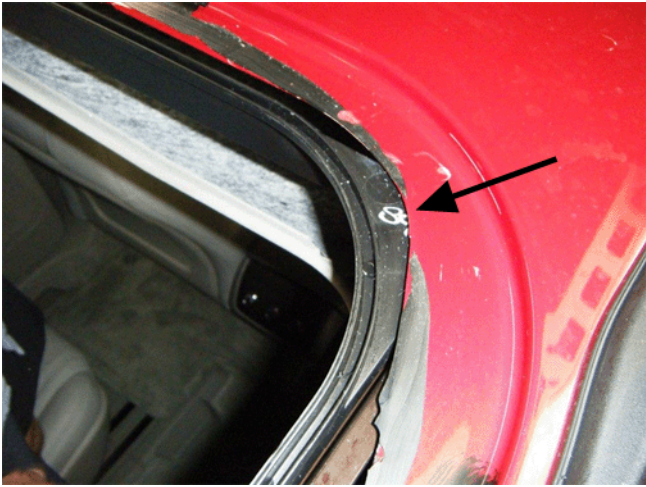
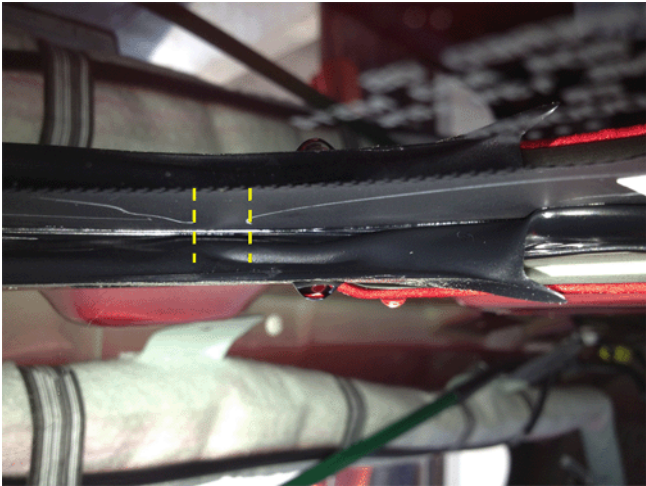
The cause of this condition may be from the urethane of the sunroof rear stationary window not sealing the glass to the body. This may allow water to leak between the urethane and roof flange, then onto the headliner.

To properly verify that the leak is from the sunroof rear stationary glass, use a soapy solution and compressed air. The more common areas where leaks may be found is at the center rear edge of the glass, or in the front or rear corners of the glass. Several examples are shown in the graphics below.

If a leak is confirmed, remove and reseal the glass. Refer to Roof Stationary Window Replacement in SI.

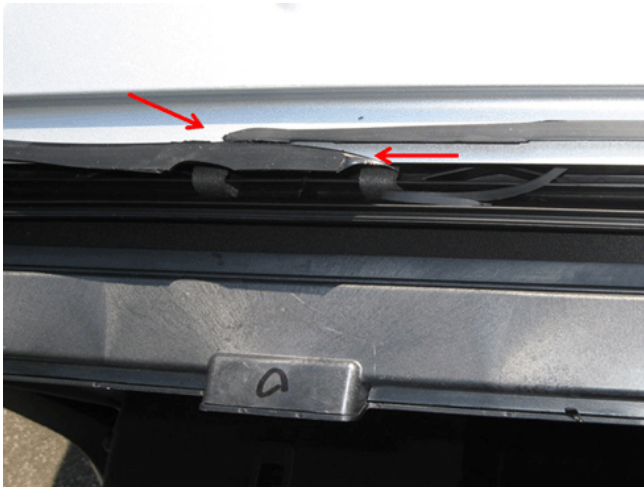
The graphic below shows an example of a leak caused by the urethane not being properly aligned.

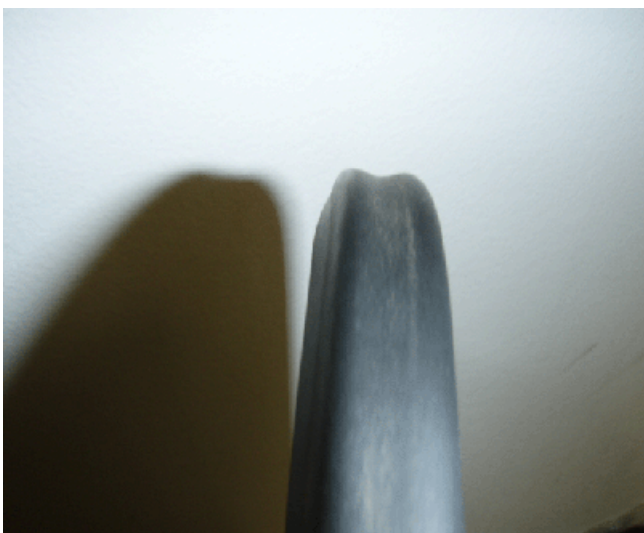
The sunroof glass panel weatherstrip/seal may have failed to retain its designed shape, resulting in a water leak that overwhelms the sunroof module water trough or allows sufficient dirt and debris into the drain location to plug up the drains.

Technicians are to inspect the glass panel weatherstrip/seal appearance at the corners and around the glass panel. If the seal looks depressed or concave in the middle, as shown above, replace the seal. Refer to Sunroof Window Weatherstrip Replacement in SI.

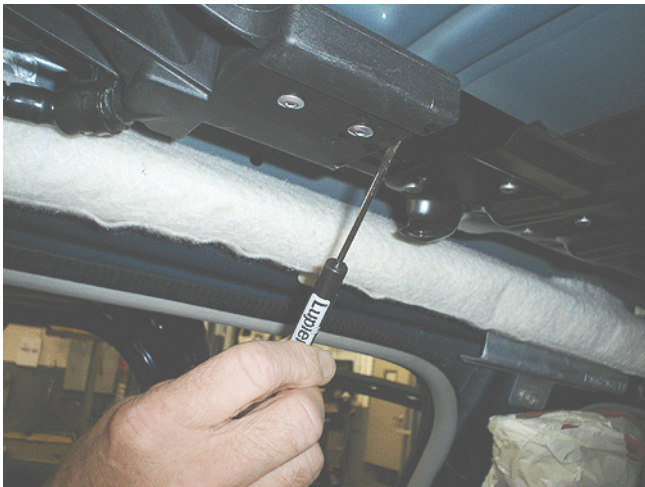
Important: Water dripping from the middle drain hose connection area, shown above, is due to the stationary glass holes leaking water, NOT the sunroof frame. Water flowing through these roof structure drain holes may miss the water management gutter, dripping onto the topside of sunroof frame and running to the underside of the frame where the black plastic drain spout attaches to the aluminum.

The primary cause of the leaks in this area could be a result of the rear stationary glass to body weatherstrip, front glass weatherstrip, or rear roof drains allowing too much water for the sunroof drain system to manage. When exceeding this threshold, the water overflows onto the headliner and into the vehicle.

TECHNICIANS MUST SEAL THESE HOLES TO STOP WATER FROM ENTERING THE VEHICLE. ONCE THESE LOCATIONS ARE SEALED, NO WATER CAN ENTER THE VEHICLE IN THESE AREAS.

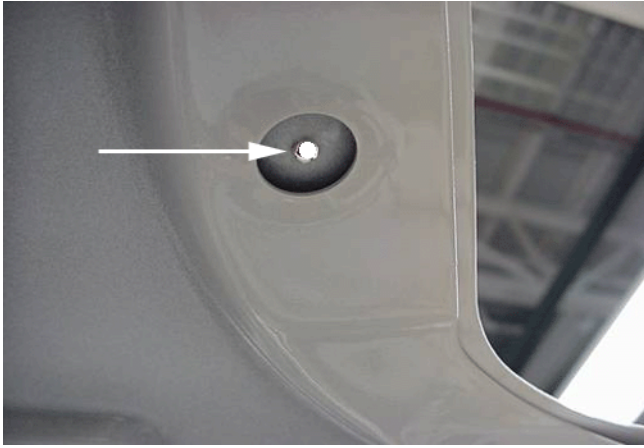
Note: The photo above, taken after the sunroof module was removed, is the view from inside the vehicle looking up at the drain holes around the rear fixed glass.

- Whether two or four holes are present, seal the holes in the roof sheet metal from inside the vehicle. Refer to the illustration above.

Important: When plugging the holes, make sure to use a windshield urethane sealant and NOT a silicone sealant. See the Parts Information section of this bulletin for the proper sealant.

Important: Ensure the urethane fills directly into the center of the hole (noted by the white area the illustration above) and pushes upward to completely seal the hole.

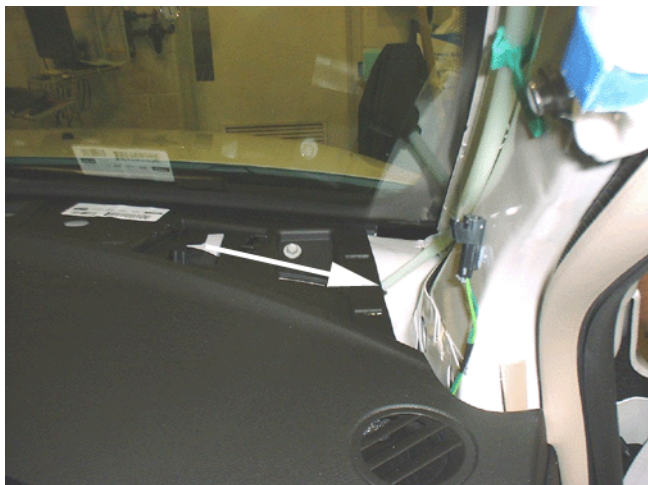
The cause of this condition may be that the end of one of the front drains may be plugged with grease from the sunroof, or debris may be caught in the cross hatch at the end of the drain tubes.

3. Remove the rubber grommet at the end of the drain tube. Refer to the illustration above.

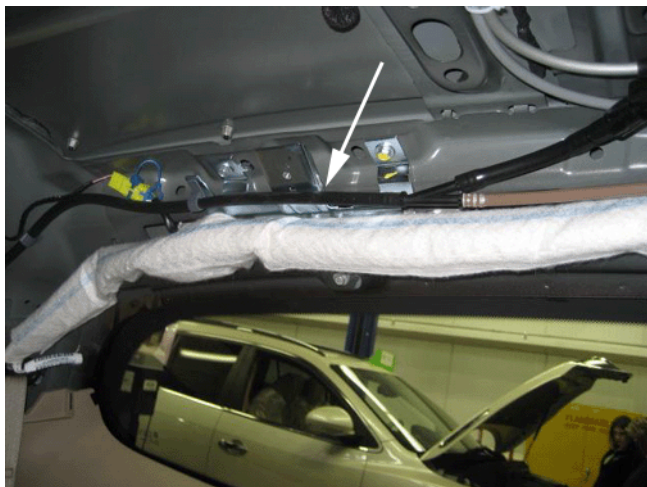
Figure 1 — Incorrect Routing

The cause of this condition may be a sunroof drain hose being improperly routed.

- Make sure that the hose is routed in back of the air bag bracket. Figure 1 shows the incorrect routing and Figure 2 shows the correct routing.
- Also make sure that there are no bends pointing upward in the drain tubes.
