Service Bulletin

Subject: Low Beam Headlamp Bulb Diagnosis/Replacement (Inspect Bulb and Connector)

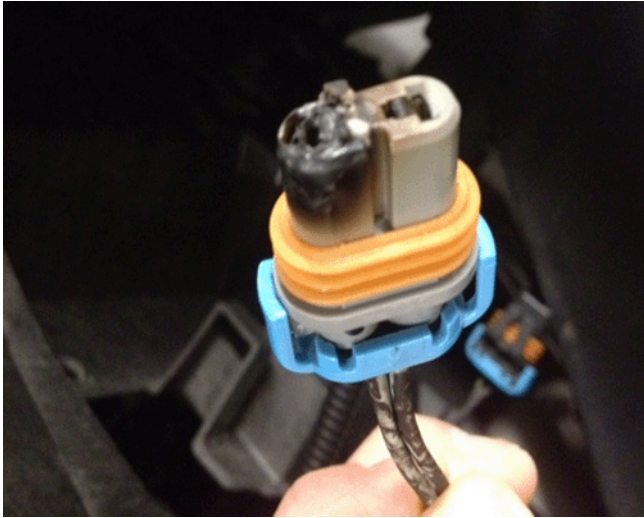
1. Remove the headlamp bulb. Refer to Headlamp Bulb Replacement procedure in SI.
2. Inspect the connector.
 - If the connector is **NOT** discolored or damaged, replace the bulb **only**. For bulb part numbers, see Headlamp Bulb (Low Beam) in Group 02.727 of the appropriate Parts Catalog.

- If the connector is discolored at the bulb interface, replace the connector (service pigtail listed below) and bulb.
3. Cut the wires of the connector approximately 45 mm (1¾ in) from the connector and splice in the service pigtail connector. Ensure that the splices are not above the connector when re-installing.
