Service Bulletin

PRELIMINARY INFORMATION

Subject: Warm Air Exhausting from Driver and/or Passenger Front Seat Back into 2nd Row Seating Area Causing Occupant Discomfort

Models: 2015 Cadillac Escalade Models
2014 Chevrolet Silverado 1500
2015 Chevrolet Silverado, Suburban, Tahoe
2014 GMC Sierra 1500
2015 GMC Sierra, Yukon Models
Equipped with Heated and Cooled Seats - Driver and Passenger Front (RPO KB6)

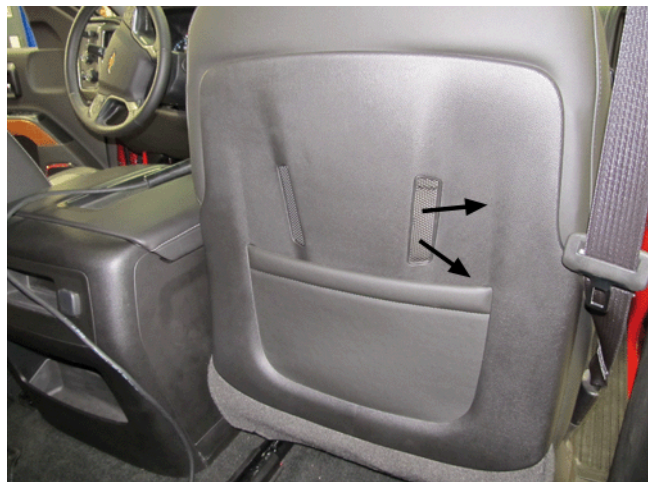
Some customers may comment on warm air exhausting from the driver/passenger front seat back into the 2nd row seating area, causing occupant discomfort.

The cause of this condition may be that during cooled seat operation, a direct flow of warm air exhausts from the upper seat back ventilation heating/cooling blower.
