Service Bulletin

PRELIMINARY INFORMATION

Subject: Spare Tire Jack Storage Compartment Door Difficult to Latch or Falls Open Due to Inability to Latch

Models: 2009-2016 GMC Acadia

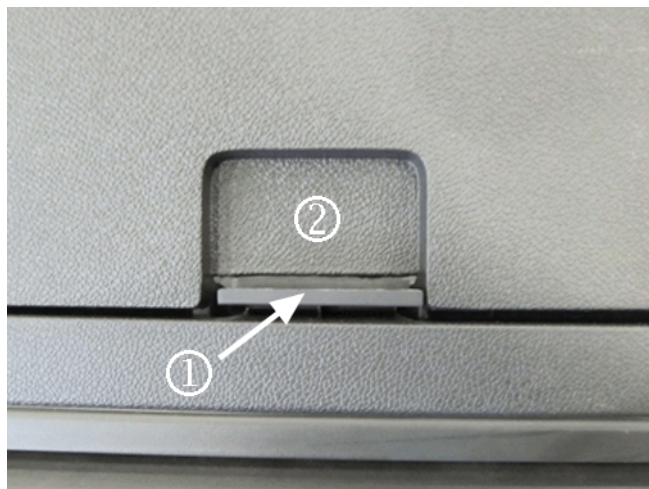
The cause of this condition may be that excessive interference may exist between the storage compartment door latch (1) and the body side trim panel (2), not allowing the door to latch properly.

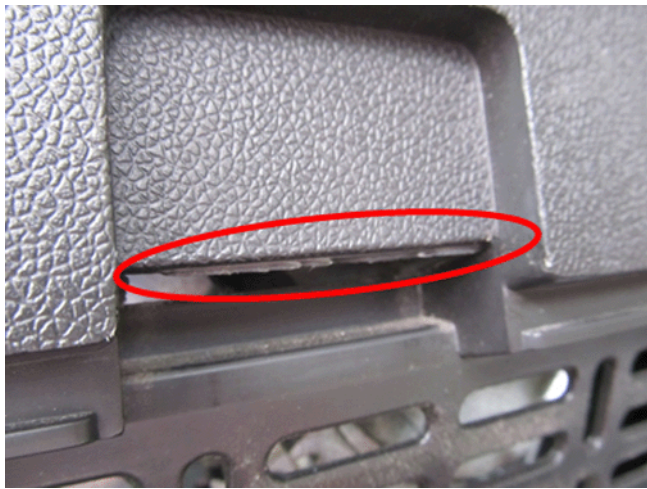
Note: The excessive flash may be folded back behind the panel and difficult to see, but it can still be detected by feeling the back side of the trim panel opening. In many cases this interference is caused by excessive flash on the inside edge of the body side trim panel opening, preventing proper engagement of the latch.
