# Service Bulletin

**Subject:** Diagnostic Tip for Malfunction Indicator Lamp (MIL) On, DTC P0454 Set

**Models:** 2013-2015 Cadillac ATS  
2014-2015 Cadillac CTS Sedan (VIN A)

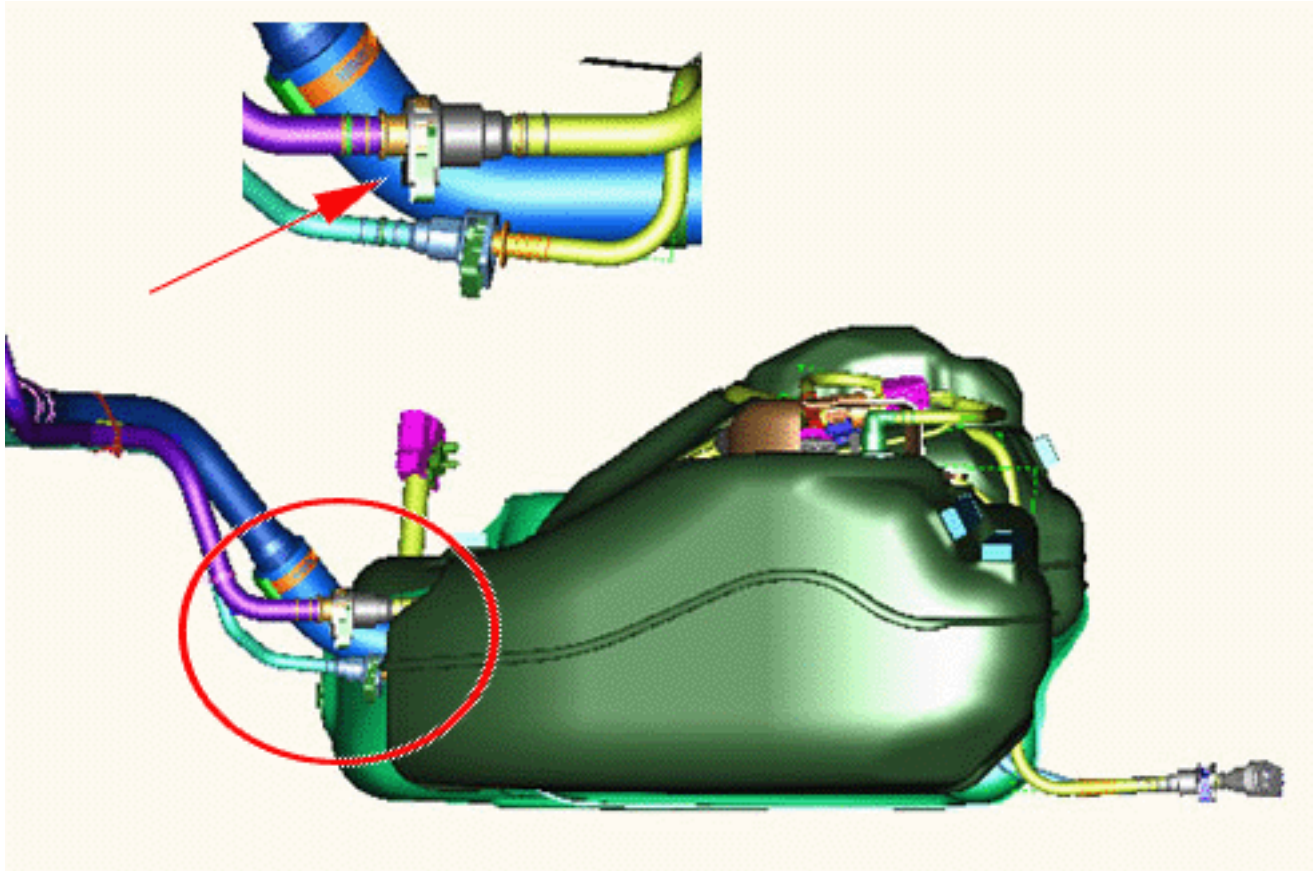
This condition may be caused by liquid fuel in the fuel tank vent line. A limited amount of fuel can enter the vapor lines in a rare combination of refueling events and vehicle maneuvers.

Normal canister purge will vaporize this fuel over time. If the small evaporative emission leak test runs when there is enough fuel in the fuel tank vent line, fuel trapped in a low area of the fuel tank vent line can block the vapor communication between the fuel tank and the fuel tank vapor pressure sensor (located on the fuel tank vent line).

With enough pressure or vacuum difference across the fuel-blocked section, vapor can bubble through the trapped fuel and cause the sensor signal to change abruptly, which the sensor diagnostic interprets as malfunction of the sensor.

1. Check for excessive fuel collecting in the 5/8" vapor line by disconnecting the line at the location shown above.
  - If there is a normal amount of fuel in the vapor line (2 tablespoons or less), then follow the published diagnostic procedures in SI for DTC P0454.

- If there is more than the normal amount of fuel in the vapor line (more than 2 tablespoons), then proceed to step 2.
2. Check the canister and replace it if it is saturated with liquid fuel. Blow out all EVAP system lines with compressed air to ensure they are dry prior to reassembling the system.
