Bulletin No.: PI1360C

Subject: Alleged No Park or Vehicle Rolls in Park or Park Will Not Hold

Models: 2013-2015 Cadillac ATS, CTS Models, Escalade Models

Equipped with 6L45, 6L50, 6L80, 6L90 Automatic Transmission (RPOs MYA, MYB, MYC, MYD)

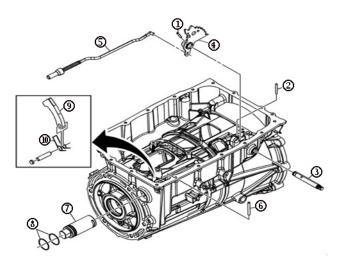
- Inspect the shift cable for proper adjustment and attachment to the range selector lever.
- Remove the transmission oil pan and inspect for debris in the pan or obvious signs of damage.
- Inspect the manual shaft detent lever assembly (4) and park pawl actuator assembly (5) for damage.
- Inspect the park gear for damage or peening of the teeth.
- Inspect the park pawl (9) and park pawl spring (10) for damage.

Note: The park pawl (9) and park pawl spring (10) are not serviced separately. If they are found to be damaged, the case assembly must be replaced.

If no damage was found during the inspection and the cause of the alleged no Park condition was not found, replace the park pawl actuator assembly (5). Refer to the part numbers listed below.
